# Environmental Inventory Report

Project Name: FEMA Mitigation Grant Management  
Project Location: Pendleton and Adams, Oregon

On behalf of:  
Confederated Tribes of the Umatilla Indian Reservation

PBS Project No. 67796.001

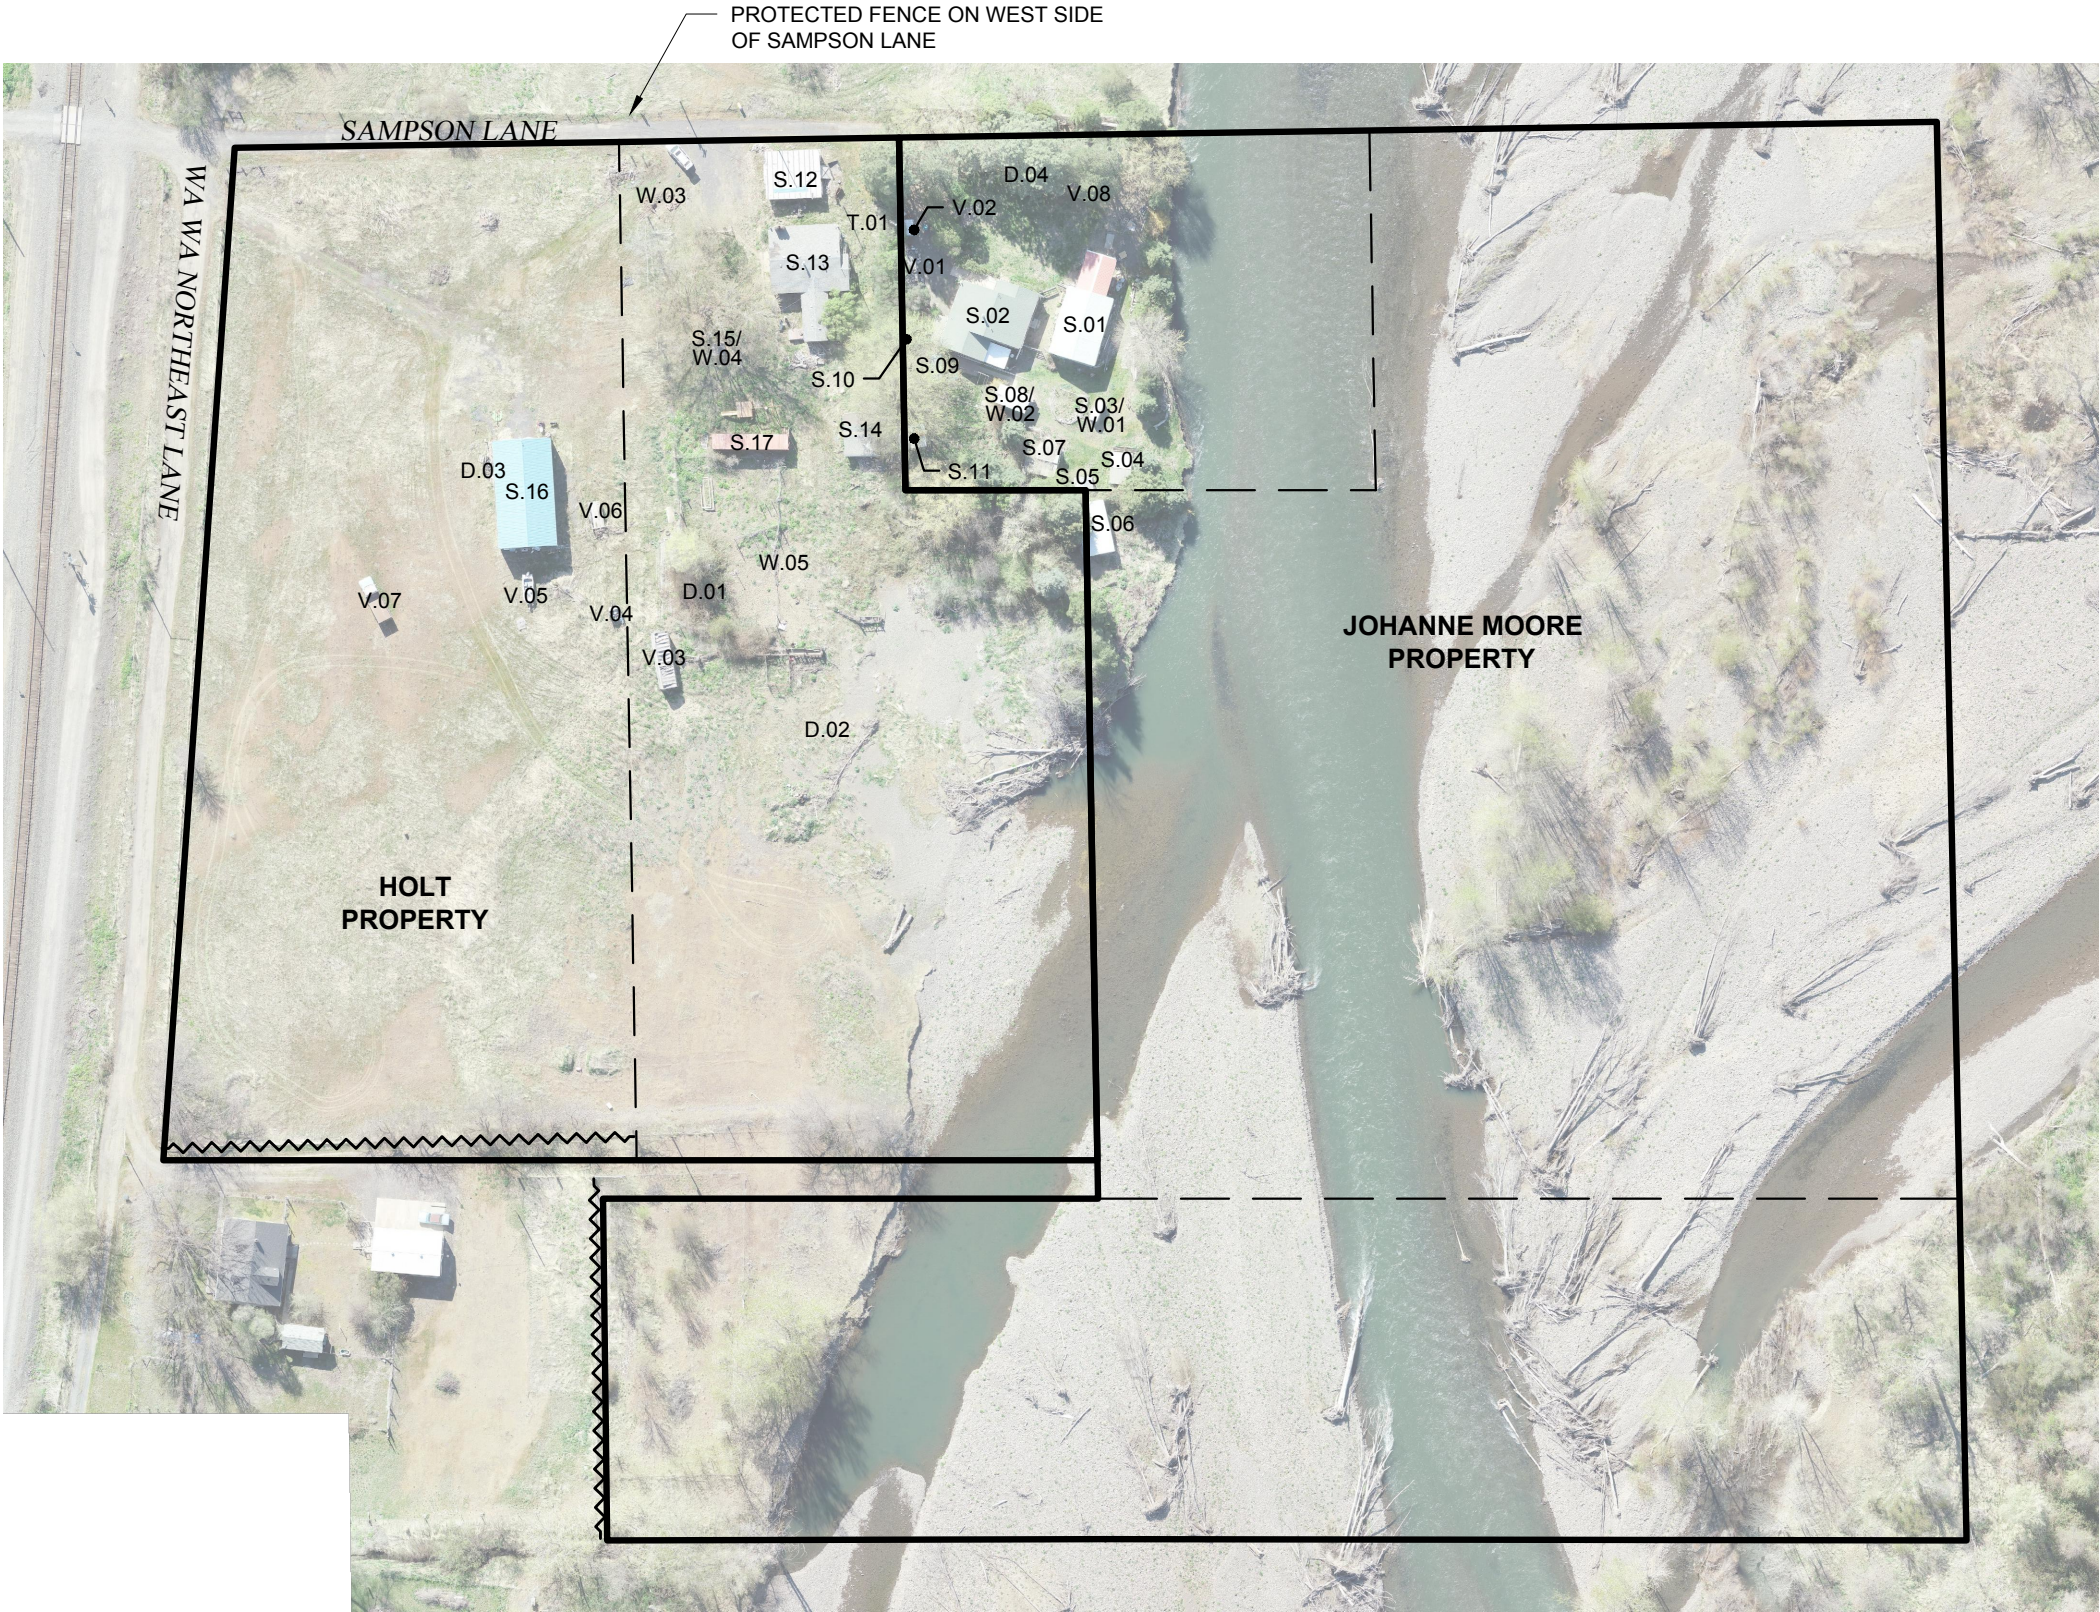
Filename: L:\Projects\67000\67796\001\Environmental\DWG\67796.001\_Fig\_1-6.dwg      Layout Tab: FIGURE 1      User: Katie Breyman      CAD Plot Date/Time: 4/30/2021 3:27:14 PM

Fencing on the property is primarily constructed from treated railroad ties and barbed wire. Fences on the property are to be removed as noted in project specifications and Drawing Sheet 1. Treated railroad tie fence posts should be disposed of in accordance with federal, state, and local regulations.

Fencing on the property is primarily constructed from treated railroad ties and barbed wire. Fences on the property are to be removed as noted in project specifications and Drawing Sheet 1. Treated railroad tie fence posts should be disposed of in accordance with local, state and federal regulations.

1. REMOVE FENCES ALONG AND WITHIN PROPERTY AND PARCEL BOUNDARIES WITH THE EXCEPTION OF PROTECTED FENCES AS NOTED IN THE DRAWING SHEET.

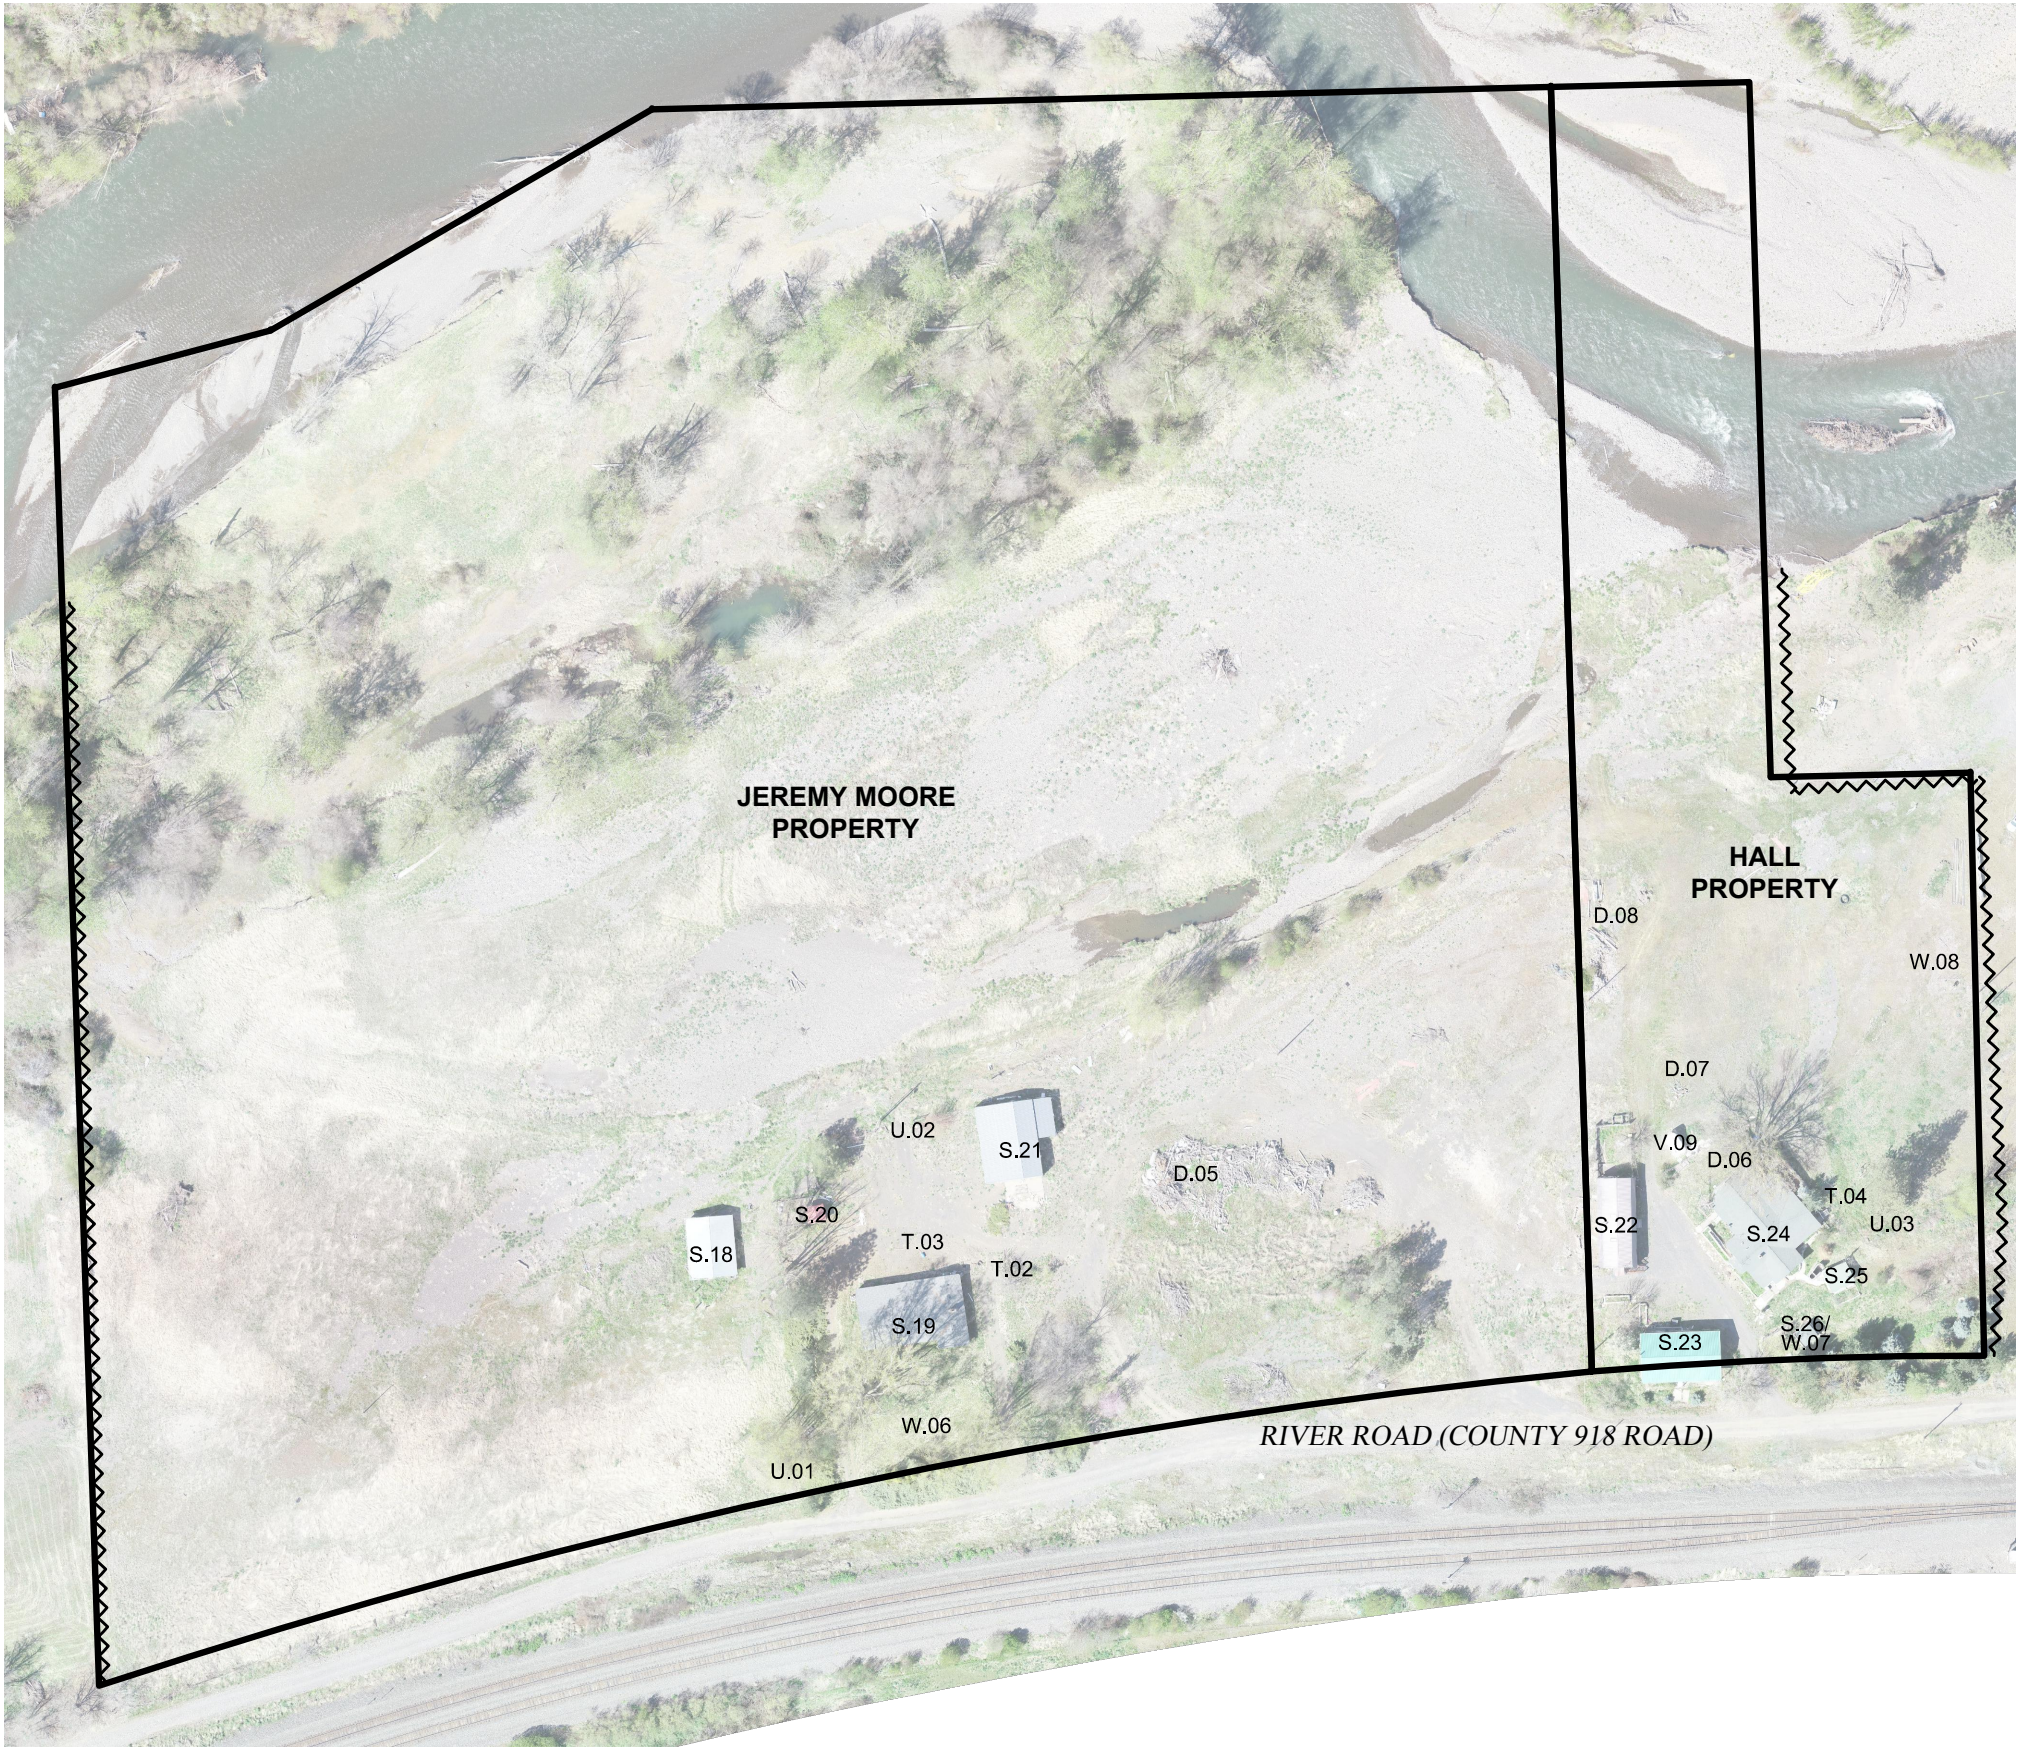
Filename: L:\Projects\67000\67796\67796-001\Environmental\DWG\67796.001\_Fig\_1-6.dwg      Layout Tab: FIGURE 2      User: Katie Breyman      CAD Plot Date/Time: 4/30/2021 3:26:47 PM

Fencing on the property is primarily constructed from treated railroad ties and barbed wire. Fences on the property are to be removed as noted in project specifications and Drawing Sheet 2. Treated railroad tie fence posts should be disposed of in accordance with local, state and federal regulations.

1. REMOVE FENCES ALONG AND WITHIN PROPERTY AND PARCEL BOUNDARIES WITH THE EXCEPTION OF PROTECTED FENCES AS NOTED IN THE DRAWING SHEET.

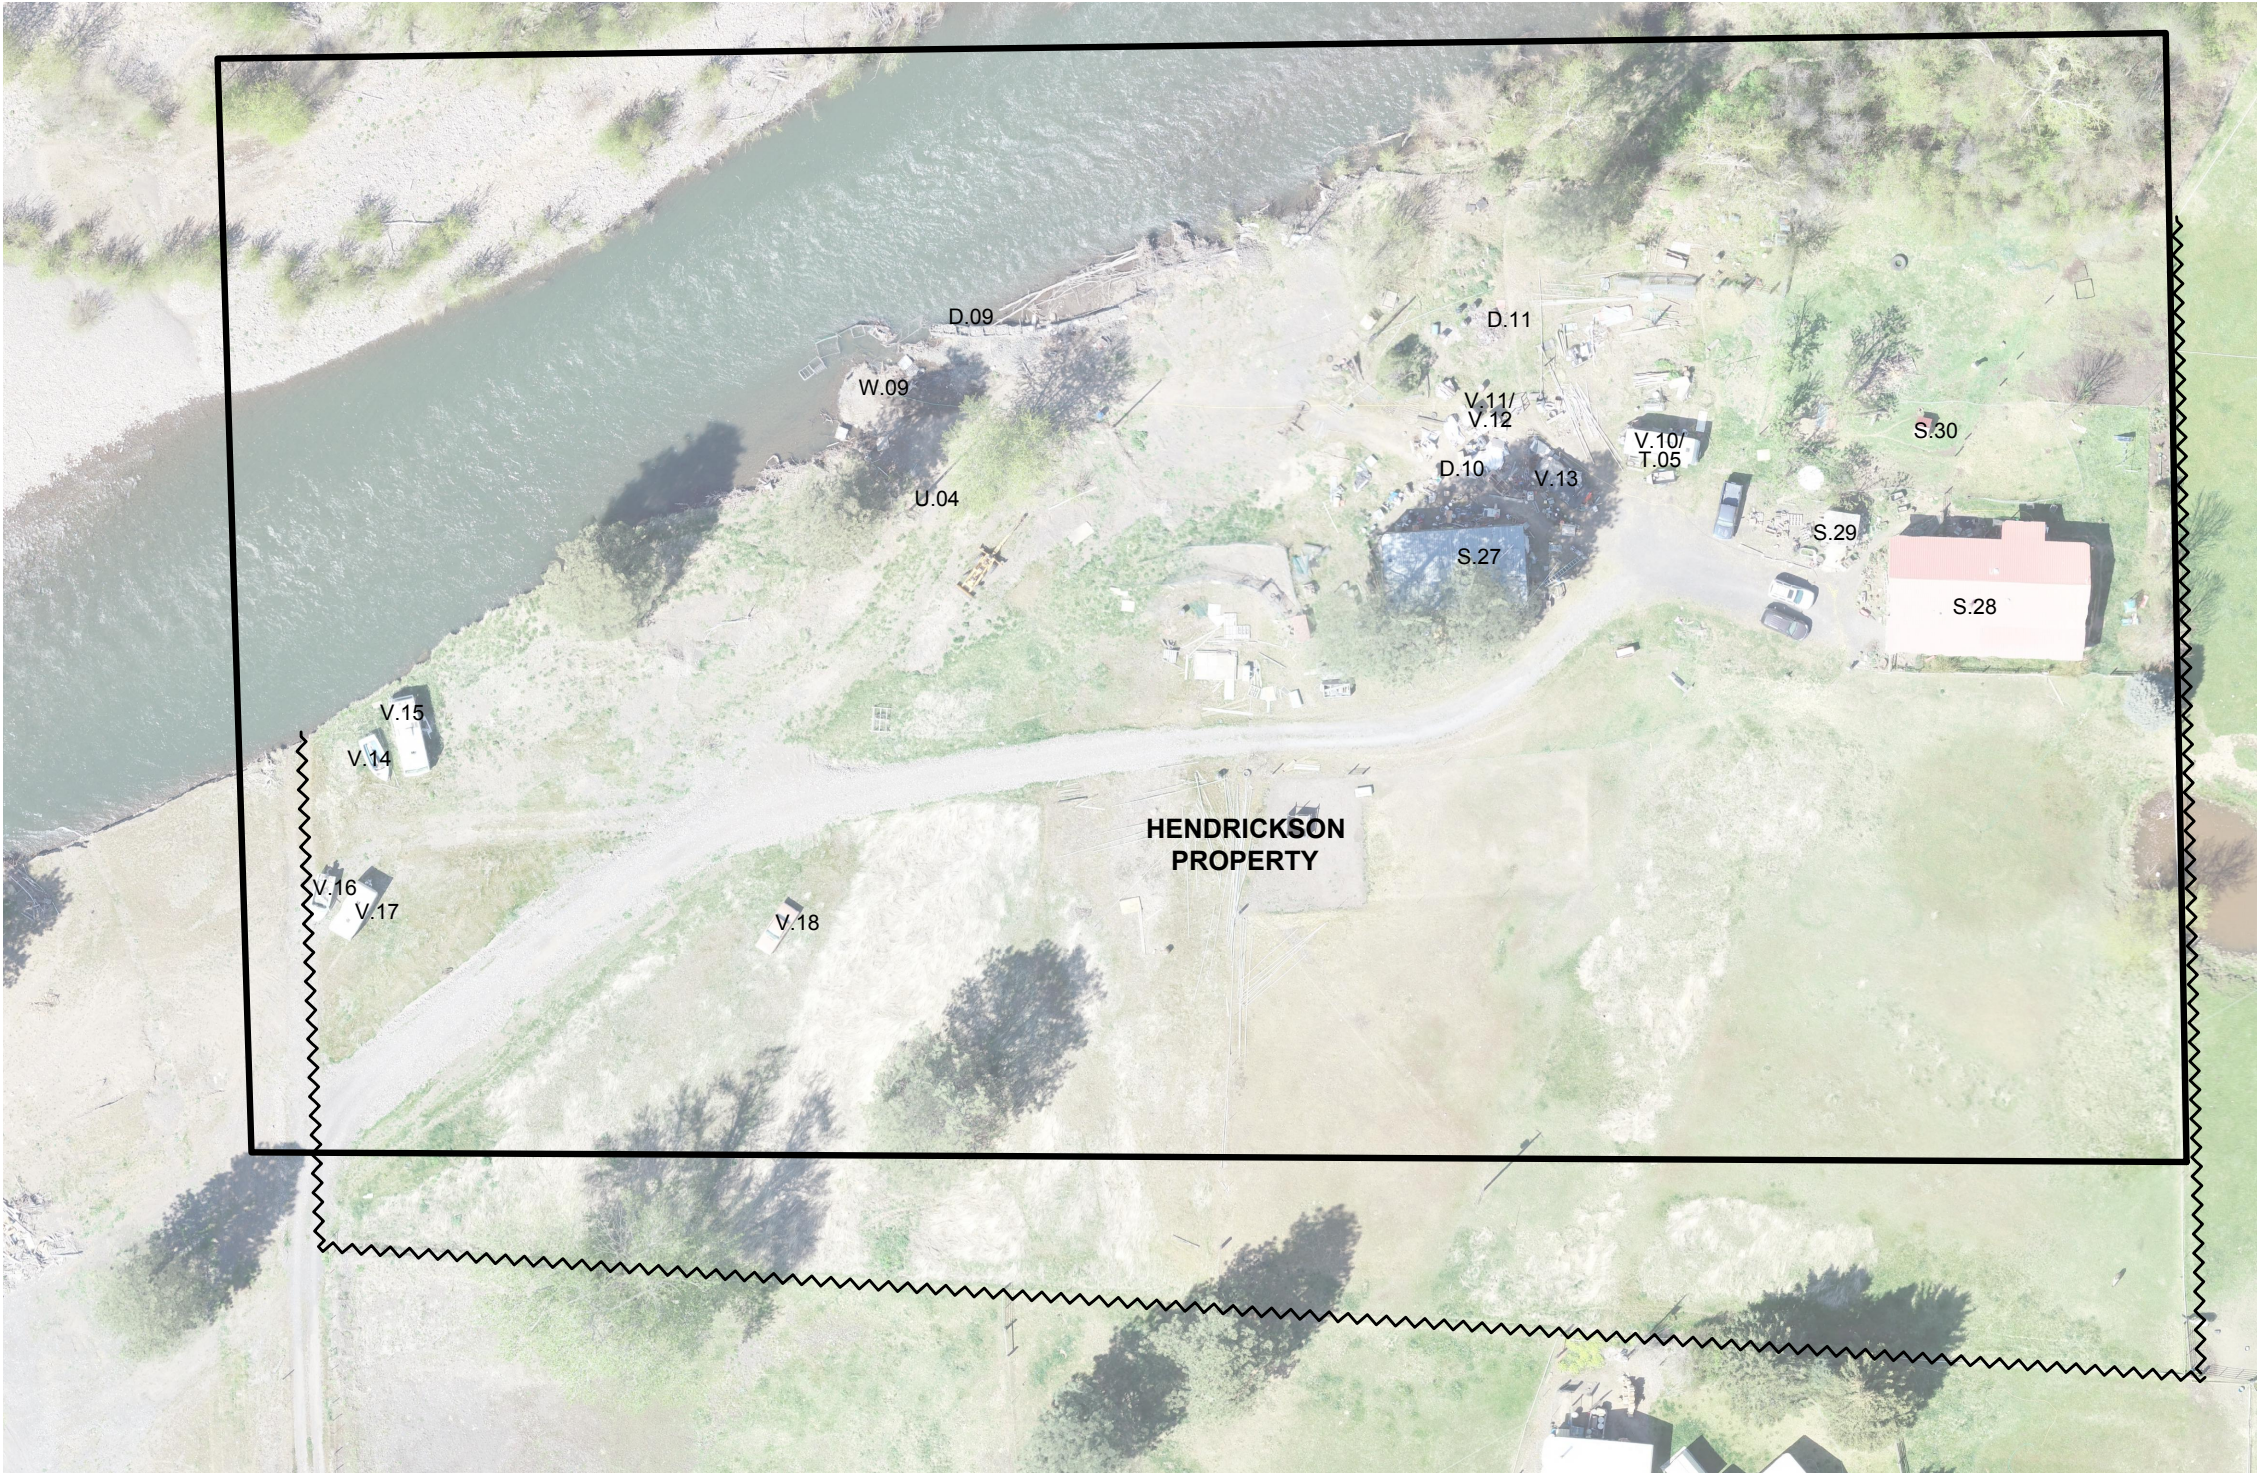
Filename: L:\Projects\67000\67796\67796-001\Environmental\DWG\67796.001\_Fig\_1-6.dwg    Layout Tab: FIGURE 3    User: Katie Breyman    CAD Plot Date/Time: 4/30/2021 3:26:08 PM

Fencing on the property is primarily constructed from treated railroad ties and barbed wire. Fences on the property are to be removed as noted in project specifications and Drawing Sheet 3. Treated railroad tie fence posts should be disposed of in accordance with local, state and federal regulations.

- Gabion baskets in river
- Fence panels/gates in river
- Abandoned equipment surrounding garage/shop (D.10)
- Quads
- Golf carts
- Claw foot tub
- Burn piles
- Empty steel drums

All manmade elements included in the debris, such as the gabion baskets, fence/gate elements, sandbags, etc. should be legally disposed of off-property by the contractor. Natural materials such as rock and sand material contained within the gabion baskets and sand bags may be removed from the baskets or sand bags and left on site. It is noted that erosion and sedimentation control measures established in Specification Section 31 10 00 – Site Clearing must be followed when removing material from levee elements to leave on site.

1. REMOVE FENCES ALONG AND WITHIN PROPERTY AND PARCEL BOUNDARIES WITH THE EXCEPTION OF PROTECTED FENCES AS NOTED IN THE DRAWING SHEET.

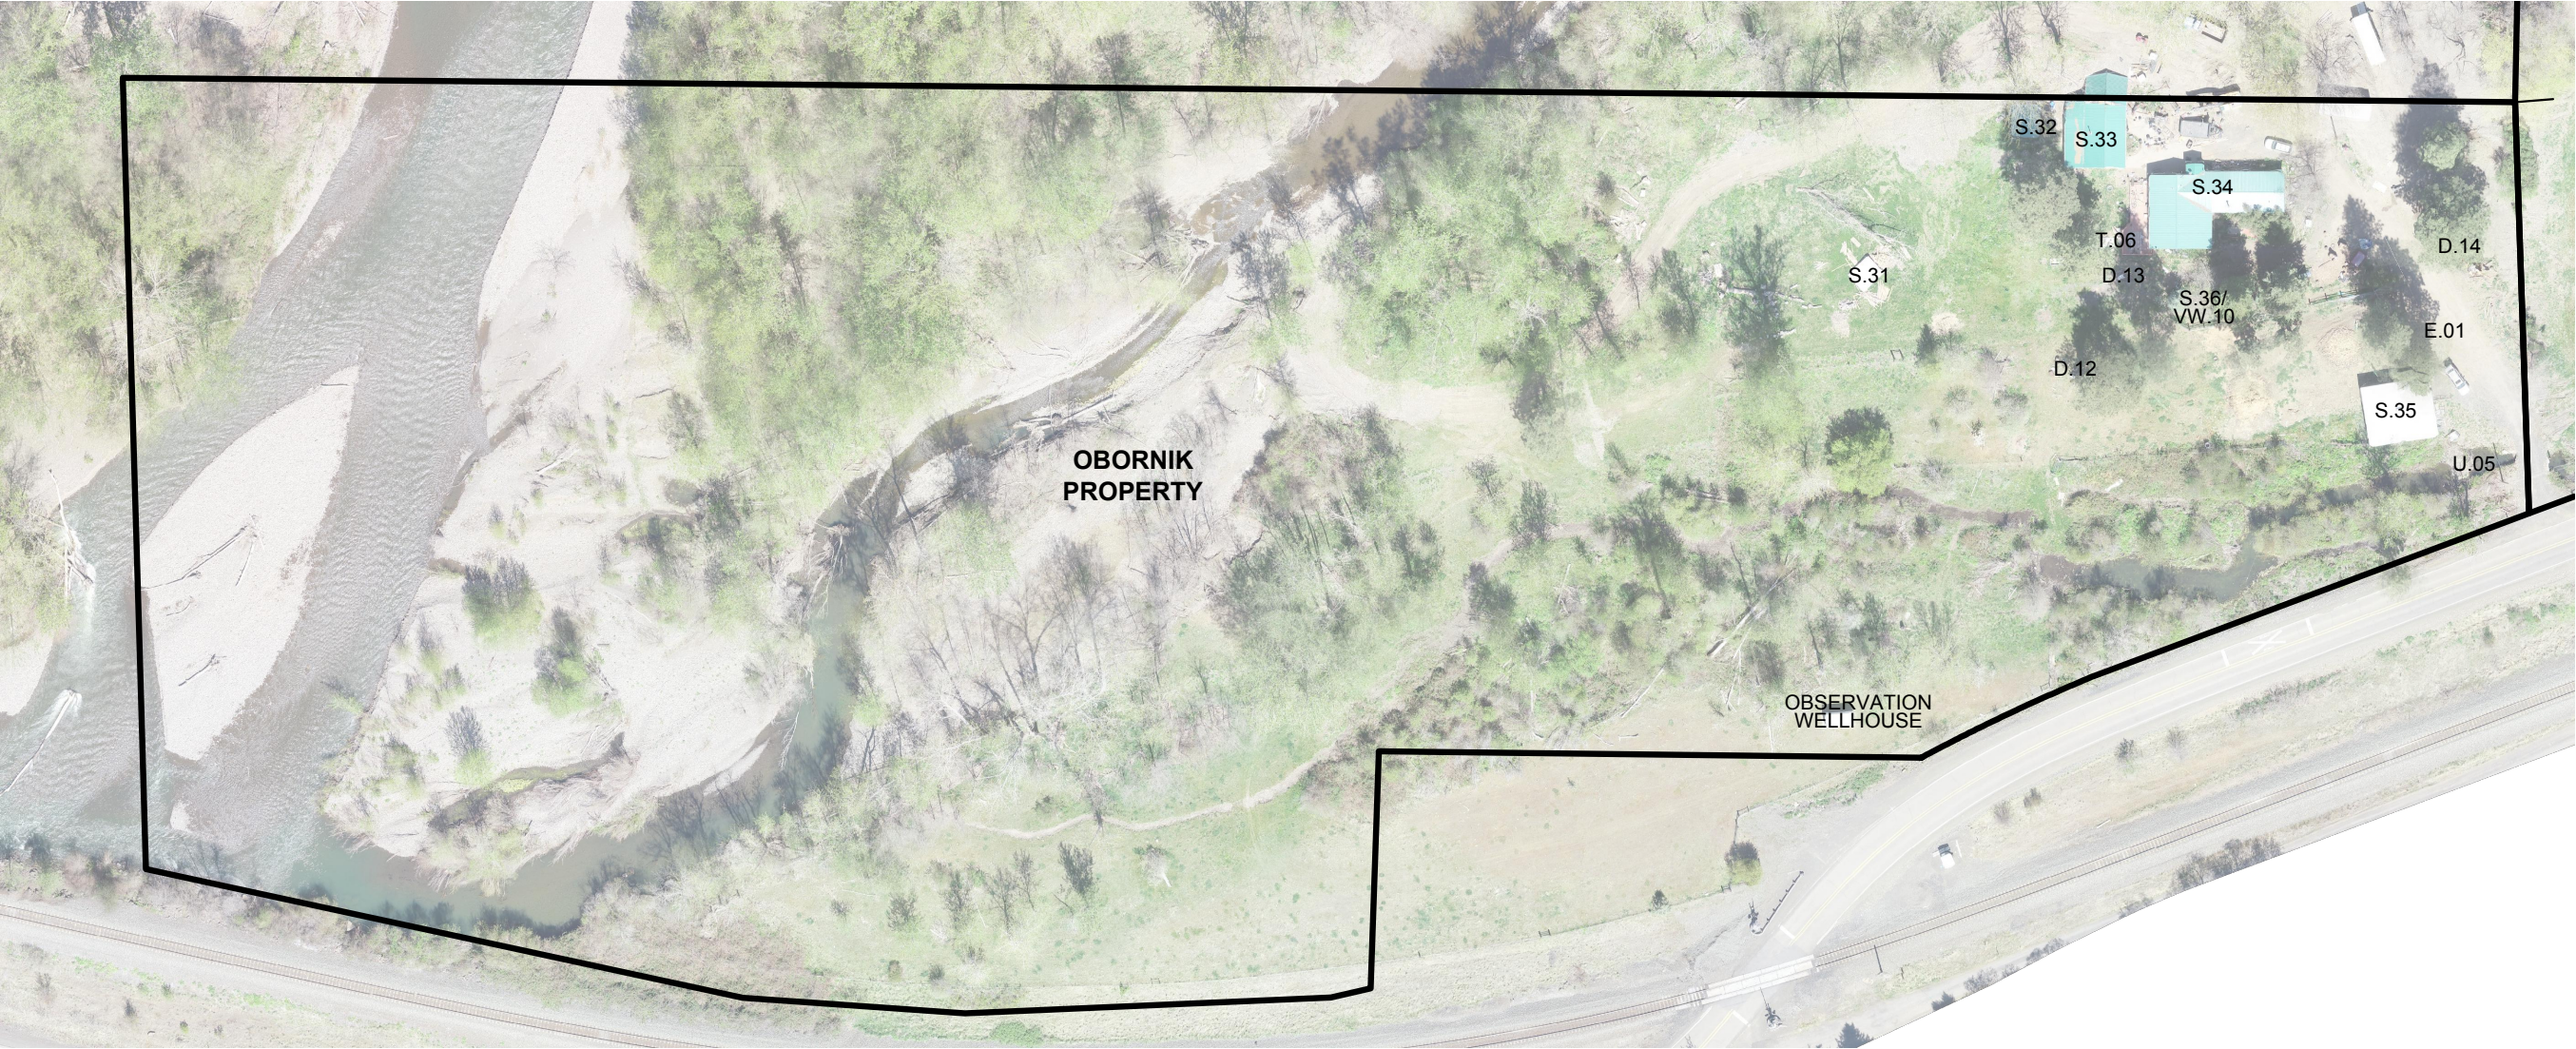
Filename: L:\Projects\6700067796-001\Environmental\DWG\67796.001\_Fig\_1-6.dwg      Layout Tab: FIGURE 4      User: Katie Breyman      CAD Plot Date/Time: 4/30/2021 3:25:35 PM

There are two observation wells located in a well house in the southern portion of the property adjacent to Cayuse Road as depicted on Drawing Sheet 4. The observation well house and wells are to be protected from damage by the contractor during site restoration. The observation well house is NOT to be demolished, altered or removed from the property, nor the wells decommissioned or altered.

Two above ground storage tanks (ASTs), approximately 500 gallons in capacity each, were observed in the southeast corner of the property on the west side of the driveway (E.01). The ASTs contain diesel fuel and have a fuel dispenser for fueling of vehicles and equipment. Minor surface spills were observed on the soil immediately beneath the diesel ASTs. It is understood that the property owner will remove the ASTs from the property. The contractor should identify the location of the former ASTs, and remove surface soil in the area as detailed in Section 7.1.

As discussed in Section 3.6.4, two diesel ASTs were observed at location E.01 on Drawing Sheet 4 on the Obornik Property. Minor surface spills were observed beneath the ASTs. It is understood that the property owner will remove the ASTs from the property.

Fencing on the property is primarily constructed from treated railroad ties and barbed wire. Fences on the property are to be removed as noted in project specifications and Drawing Sheet 4. Treated railroad tie fence posts should be disposed of in accordance with local, state and federal regulations.

In addition to domestic supply wells, two observation wells are located within a well house at the Obornik Property within the greater Project Site. The observation wells and well house are to be protected from damage by the contractor during site restoration work. Do NOT decommission, damage or otherwise alter the observation wells or well house. See Drawing Sheet 4 for the location of the observation well house.

1. REMOVE FENCES ALONG AND WITHIN PROPERTY AND PARCEL BOUNDARIES WITH THE EXCEPTION OF PROTECTED FENCES AS NOTED IN THE DRAWING SHEET.
2. OBSERVATION WELL HOUSE AND AND OBSERVATION WELLS WILL BE PROTECTED FROM DAMAGE BY THE CONTRACTOR.

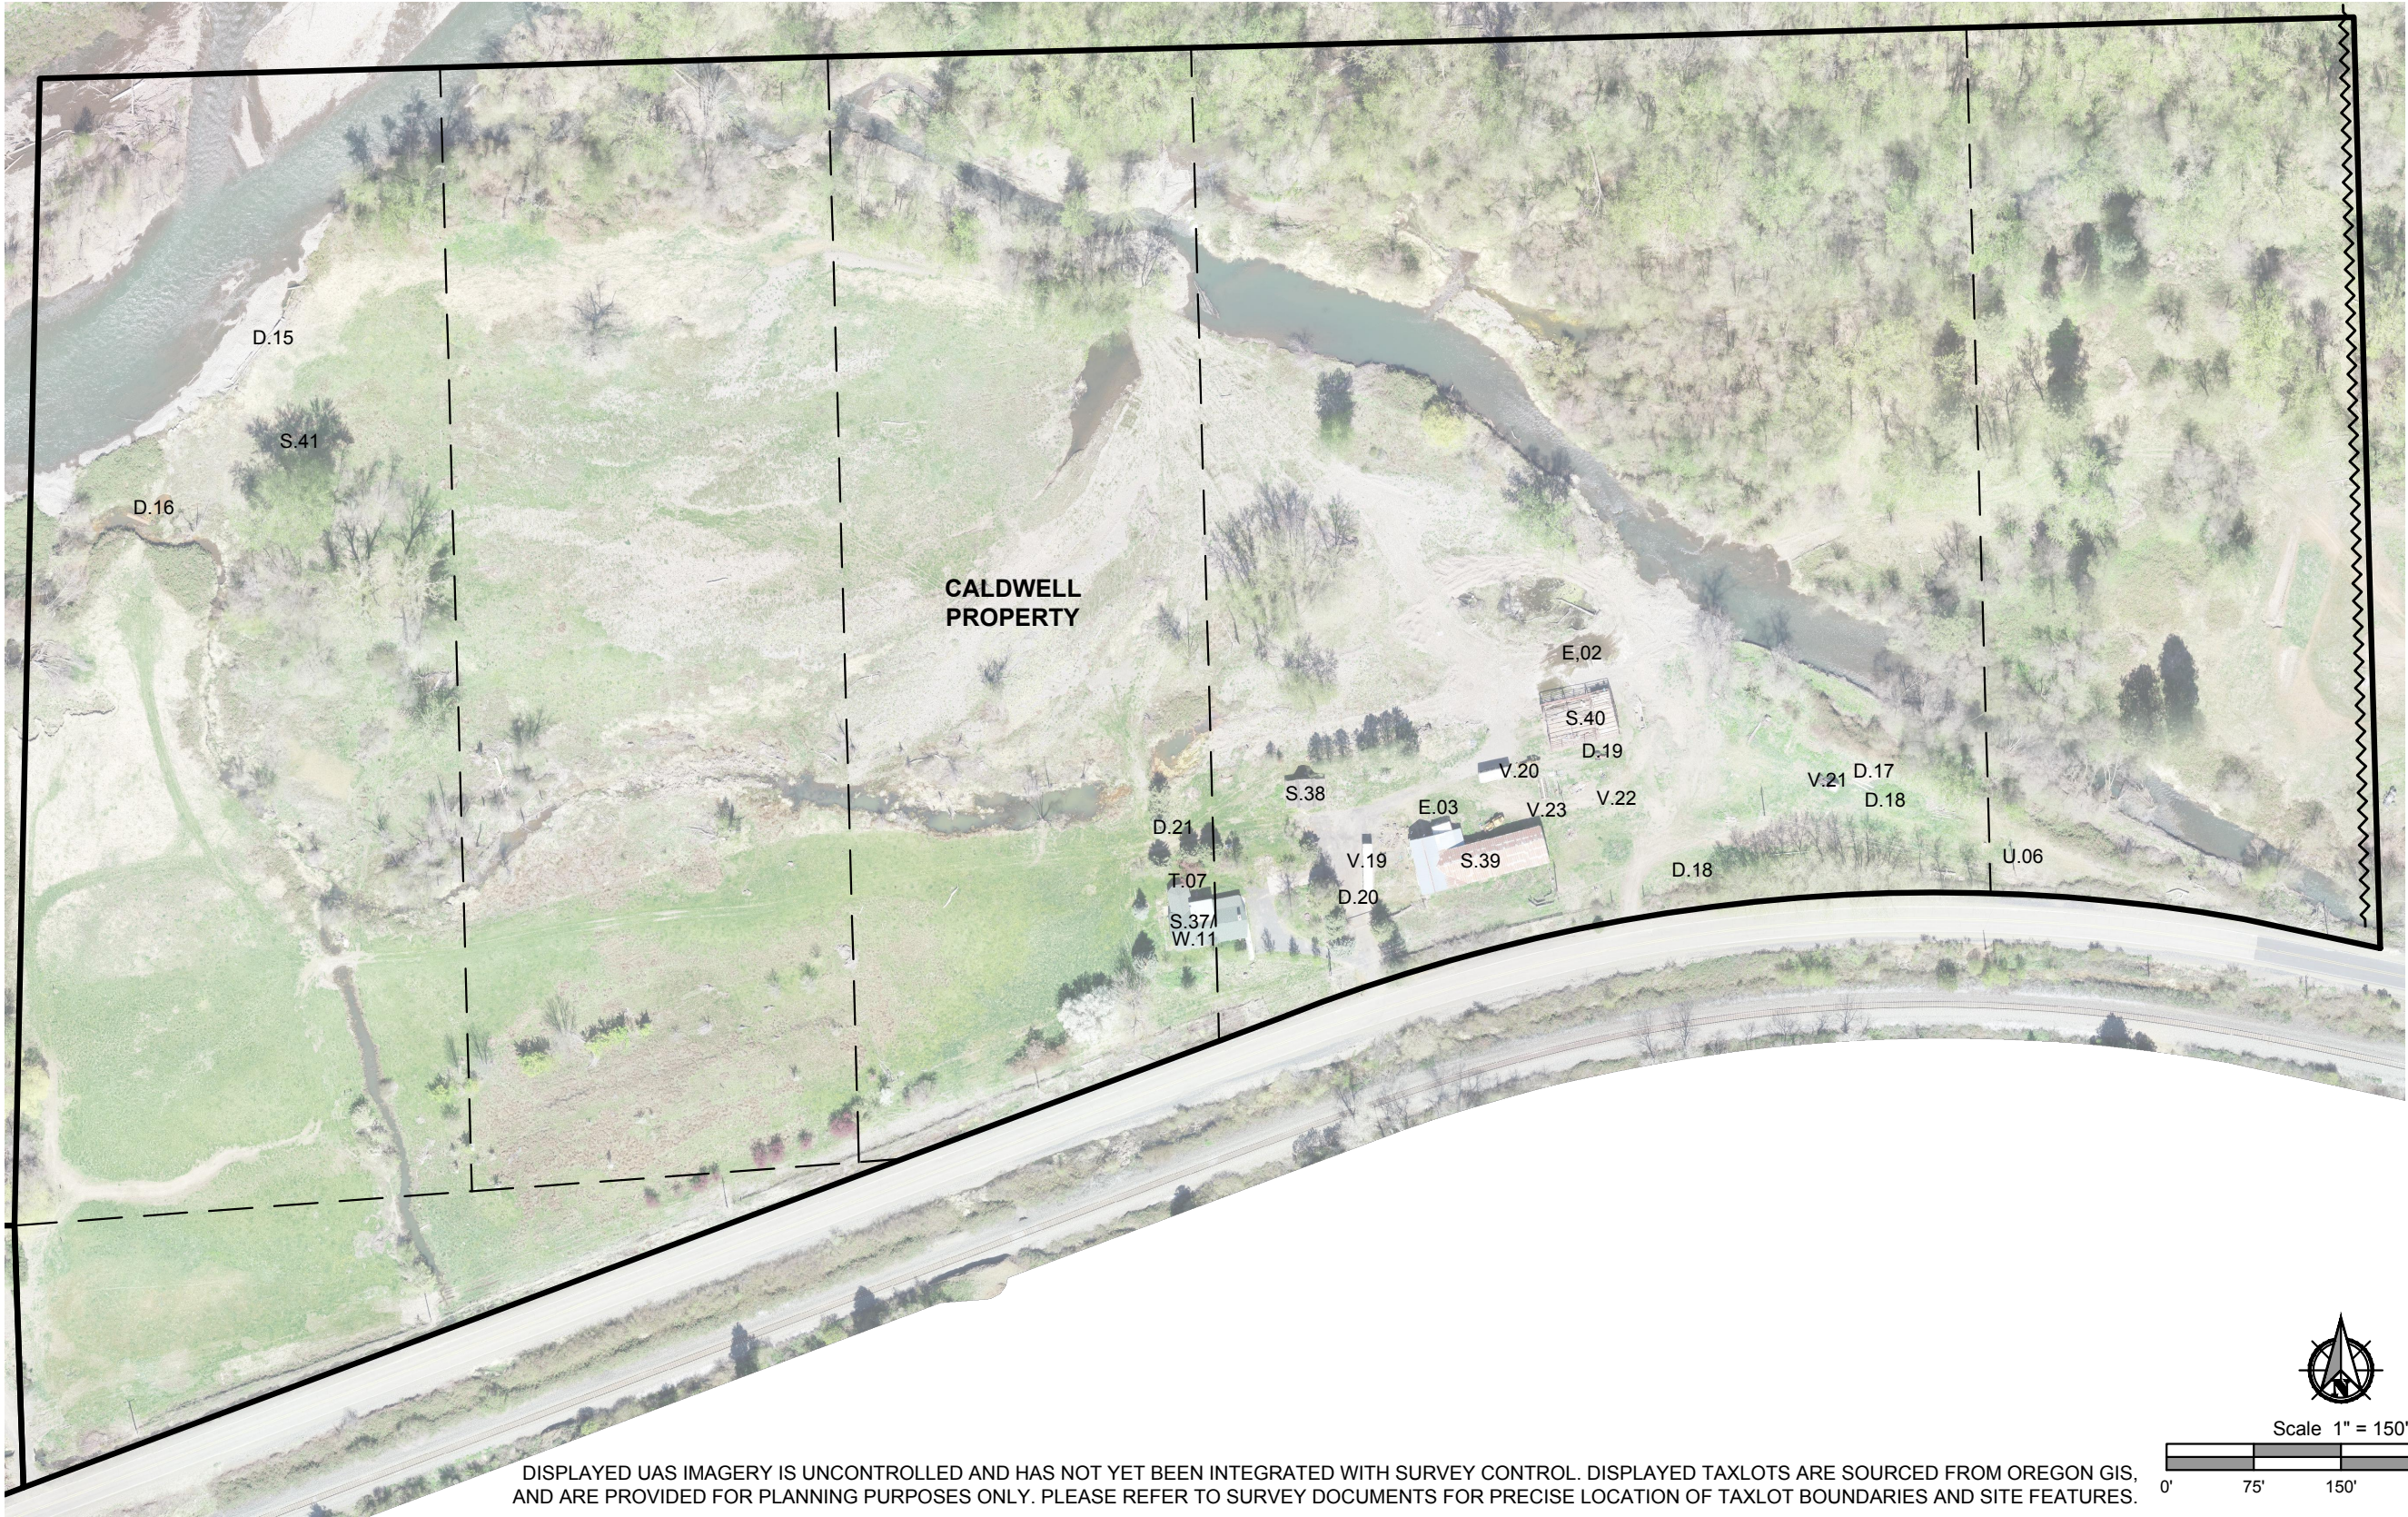
The Caldwell Property is improved with five structures (S.37 through S.41) including a house, an in-law unit, a shop/barn, a steel framed shop/warehouse and a hunting blind (see Drawing Sheet 5). It is noted that the shop/barn (S.39) is a combination of multiple construction types and is surrounded by several freestanding trailers and sheds. For the purposes of this report they are treated as one structure. The contractor should reference the Hazardous Building Materials Report for disposal requirements for the individual elements of this greater structure.

Based on a phone interview with the property owner, the former residence on the property, located to the east of the current house, operated an oil burning furnace and associated heating oil tank (E.03). The tank was partially buried below-ground and partially exposed above-ground. The tank was removed from the property approximately 50 years ago by the property owner, and was reported to be leaking at the time of removal. The approximate location of the former heating oil tank is depicted on Drawing Sheet 5. The contractor should follow unexpected discovery protocols established in Section 8 when working in the vicinity of the former heating oil tank.

Additionally, a waste oil drum (E.02) was observed in the west end of the shop/barn (S.39) near the garage door. Minor surface spills were observed on the concrete slab in the vicinity of the waste oil drum. Contents of the waste oil drum should be disposed of in accordance with local, state and federal regulations. The contractor should follow unexpected discovery protocols established in Section 8 when working in the vicinity of the waste oil drum, as depicted on Drawing Sheet 5.

A waste oil container was observed in structure S.39 at the Caldwell Property. The container is marked as location E.03 on Drawing Sheet 5. Minor surface spills were observed on the concrete slab in the vicinity of the waste oil container. Following proper removal and disposal of the waste oil container and removal of the underlying slab, the contractor shall follow unanticipated discovery protocols established in Section 8 of this report when working in the vicinity of the waste oil container.

Fencing on the property is primarily constructed from treated railroad ties and barbed wire. Fences on the property are to be removed as noted in project specifications and Drawing Sheet 5. Treated railroad tie fence posts should be disposed of in accordance with local, state and federal regulations.

All manmade elements included in the debris, such as the ecoblocks, steel culvert or other manmade materials observed along the riverbank should be legally disposed of off property by the contractor.

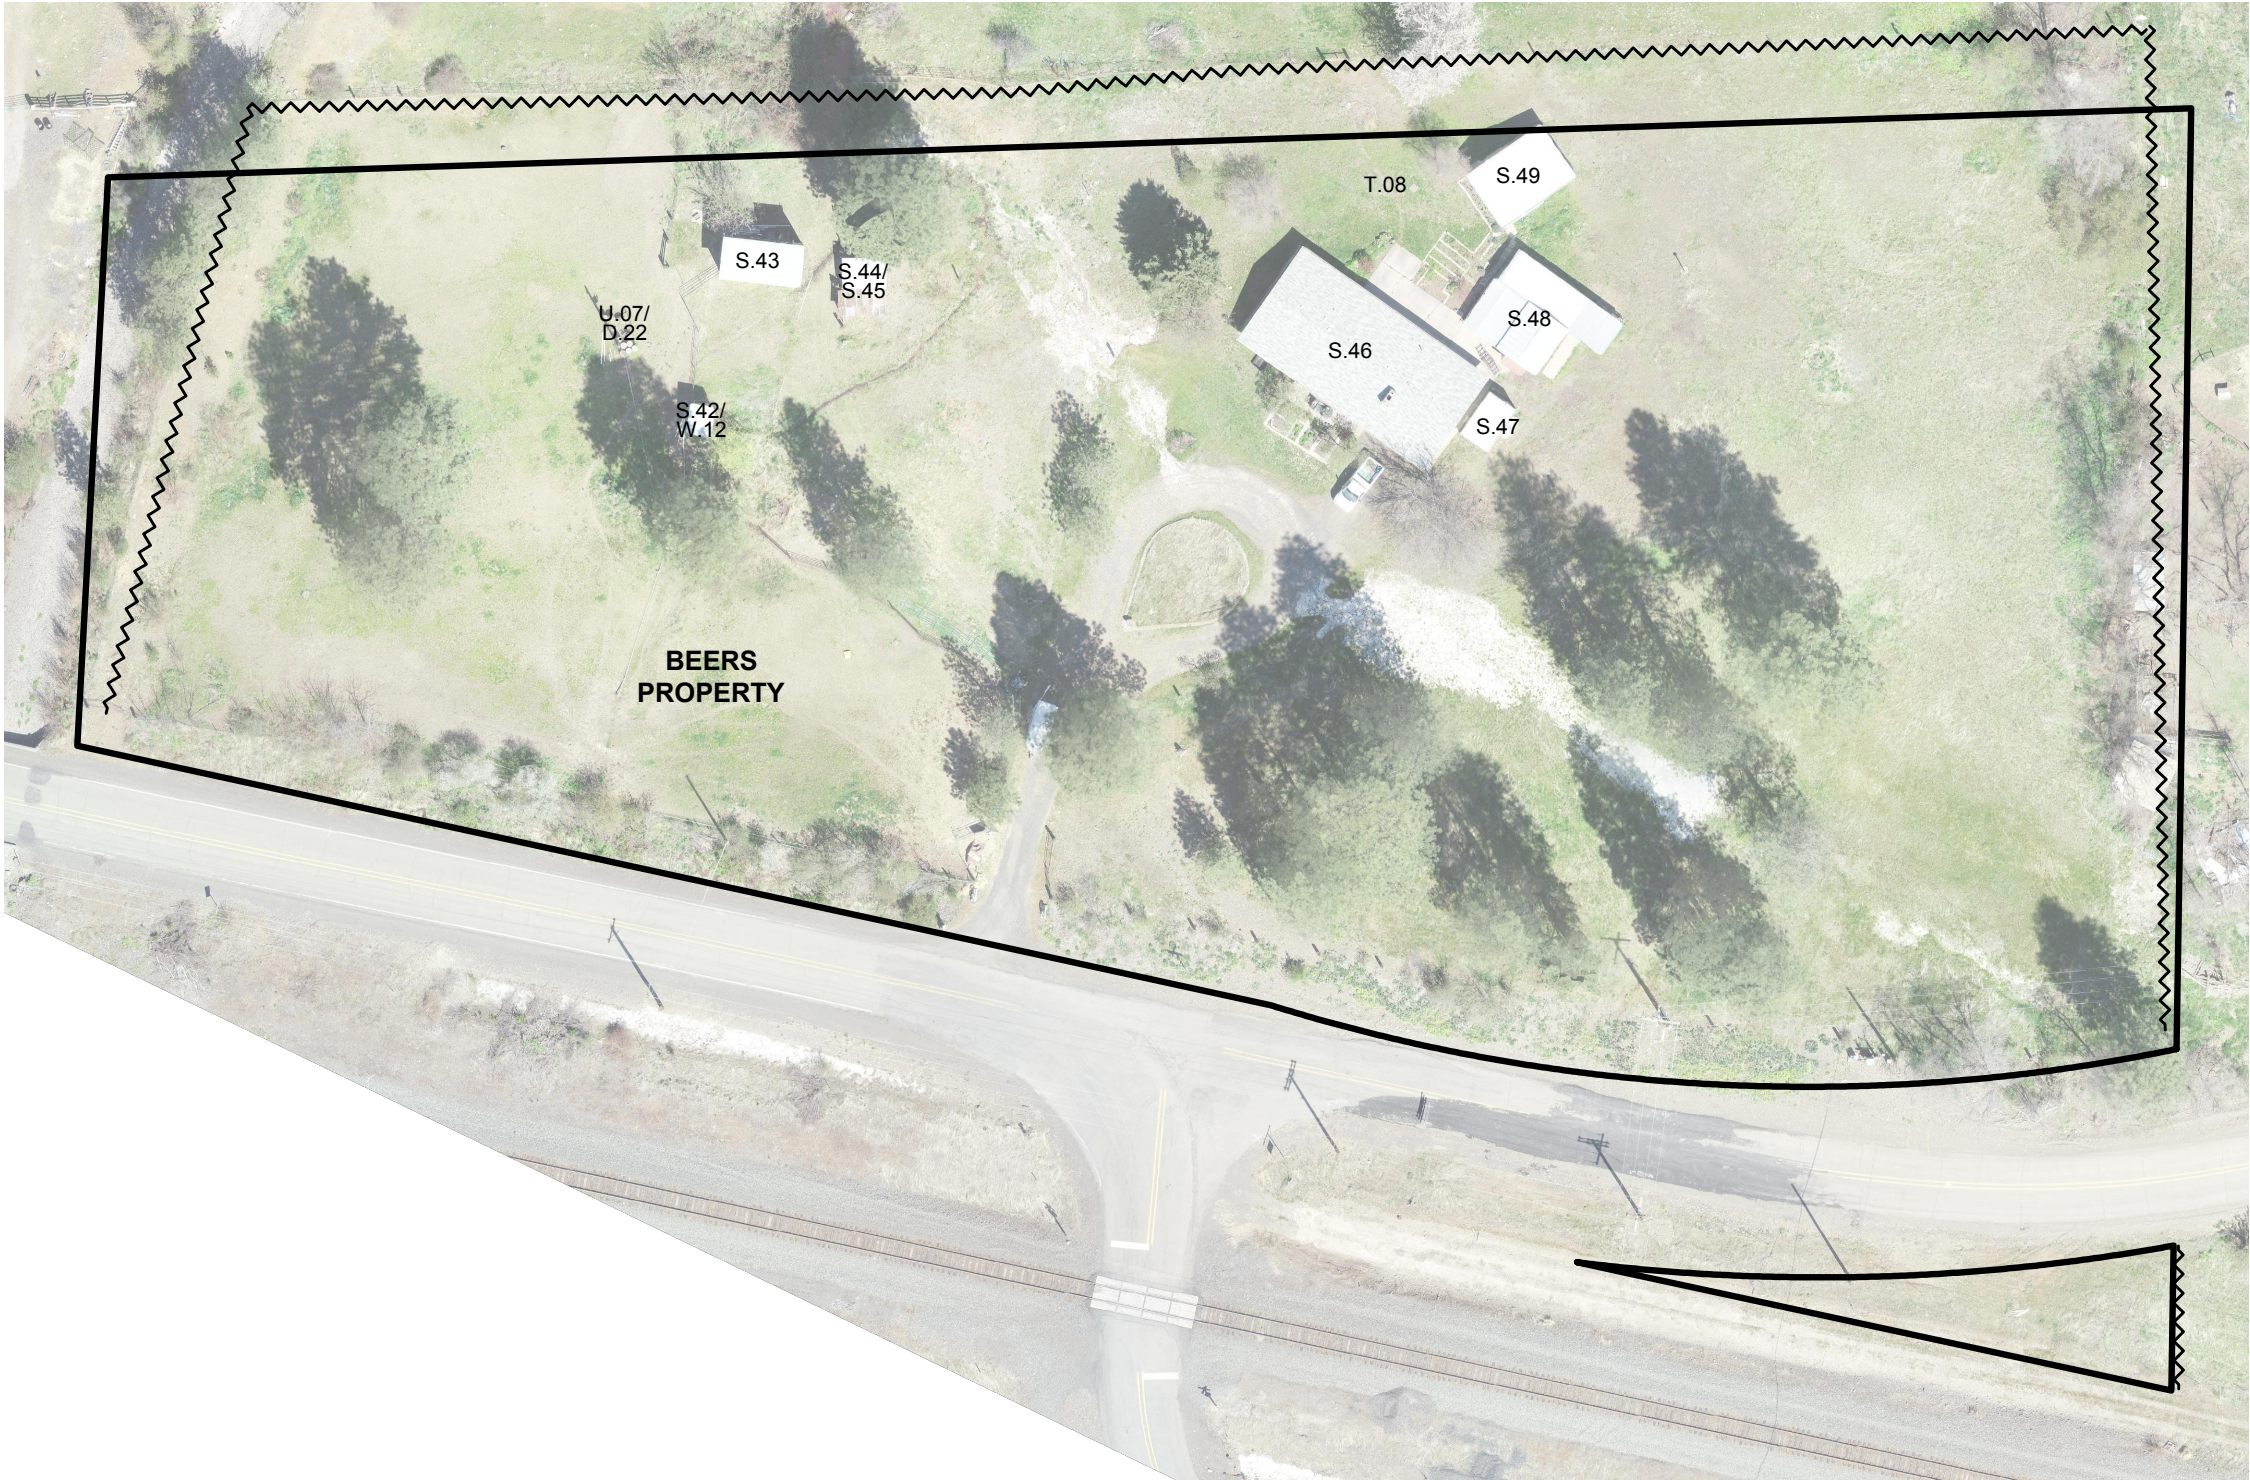
Filename: L:\Projects\67796\67796-001\Environmental\DWG\67796.001\_Fig\_1-6.dwg    Layout Tab: FIGURE 6    User: Katie Breyman    CAD Plot Date/Time: 4/30/2021 3:24:05 PM

Fencing on the property is primarily constructed from treated railroad ties and barbed wire. Fences on the property are to be removed as noted in project specifications and Drawing Sheet 6. Treated railroad tie fence posts should be disposed of in accordance with local, state and federal regulations.

1. REMOVE FENCES ALONG AND WITHIN PROPERTY AND PARCEL BOUNDARIES WITH THE EXCEPTION OF PROTECTED FENCES AS NOTED IN THE DRAWING SHEET.
