TECHNICAL MEMORANDUM #2: CONTEXT AND SITE ANALYSIS

Date:	June 30, 2022	Project #: 23021.046
To:	Dani Schulte, CTUIR Cheryl-Jarvis Smith, ODOT Region 5	
From:	Molly McCormick, Nick Foster AICP, RSP1, and Matt Hughart, AICP	
Project:	Confederated Tribes of Umatilla Indian Reservation Transportation System Plan Upo	date
Subject:	Tech Memo #2: Context and Site Analysis

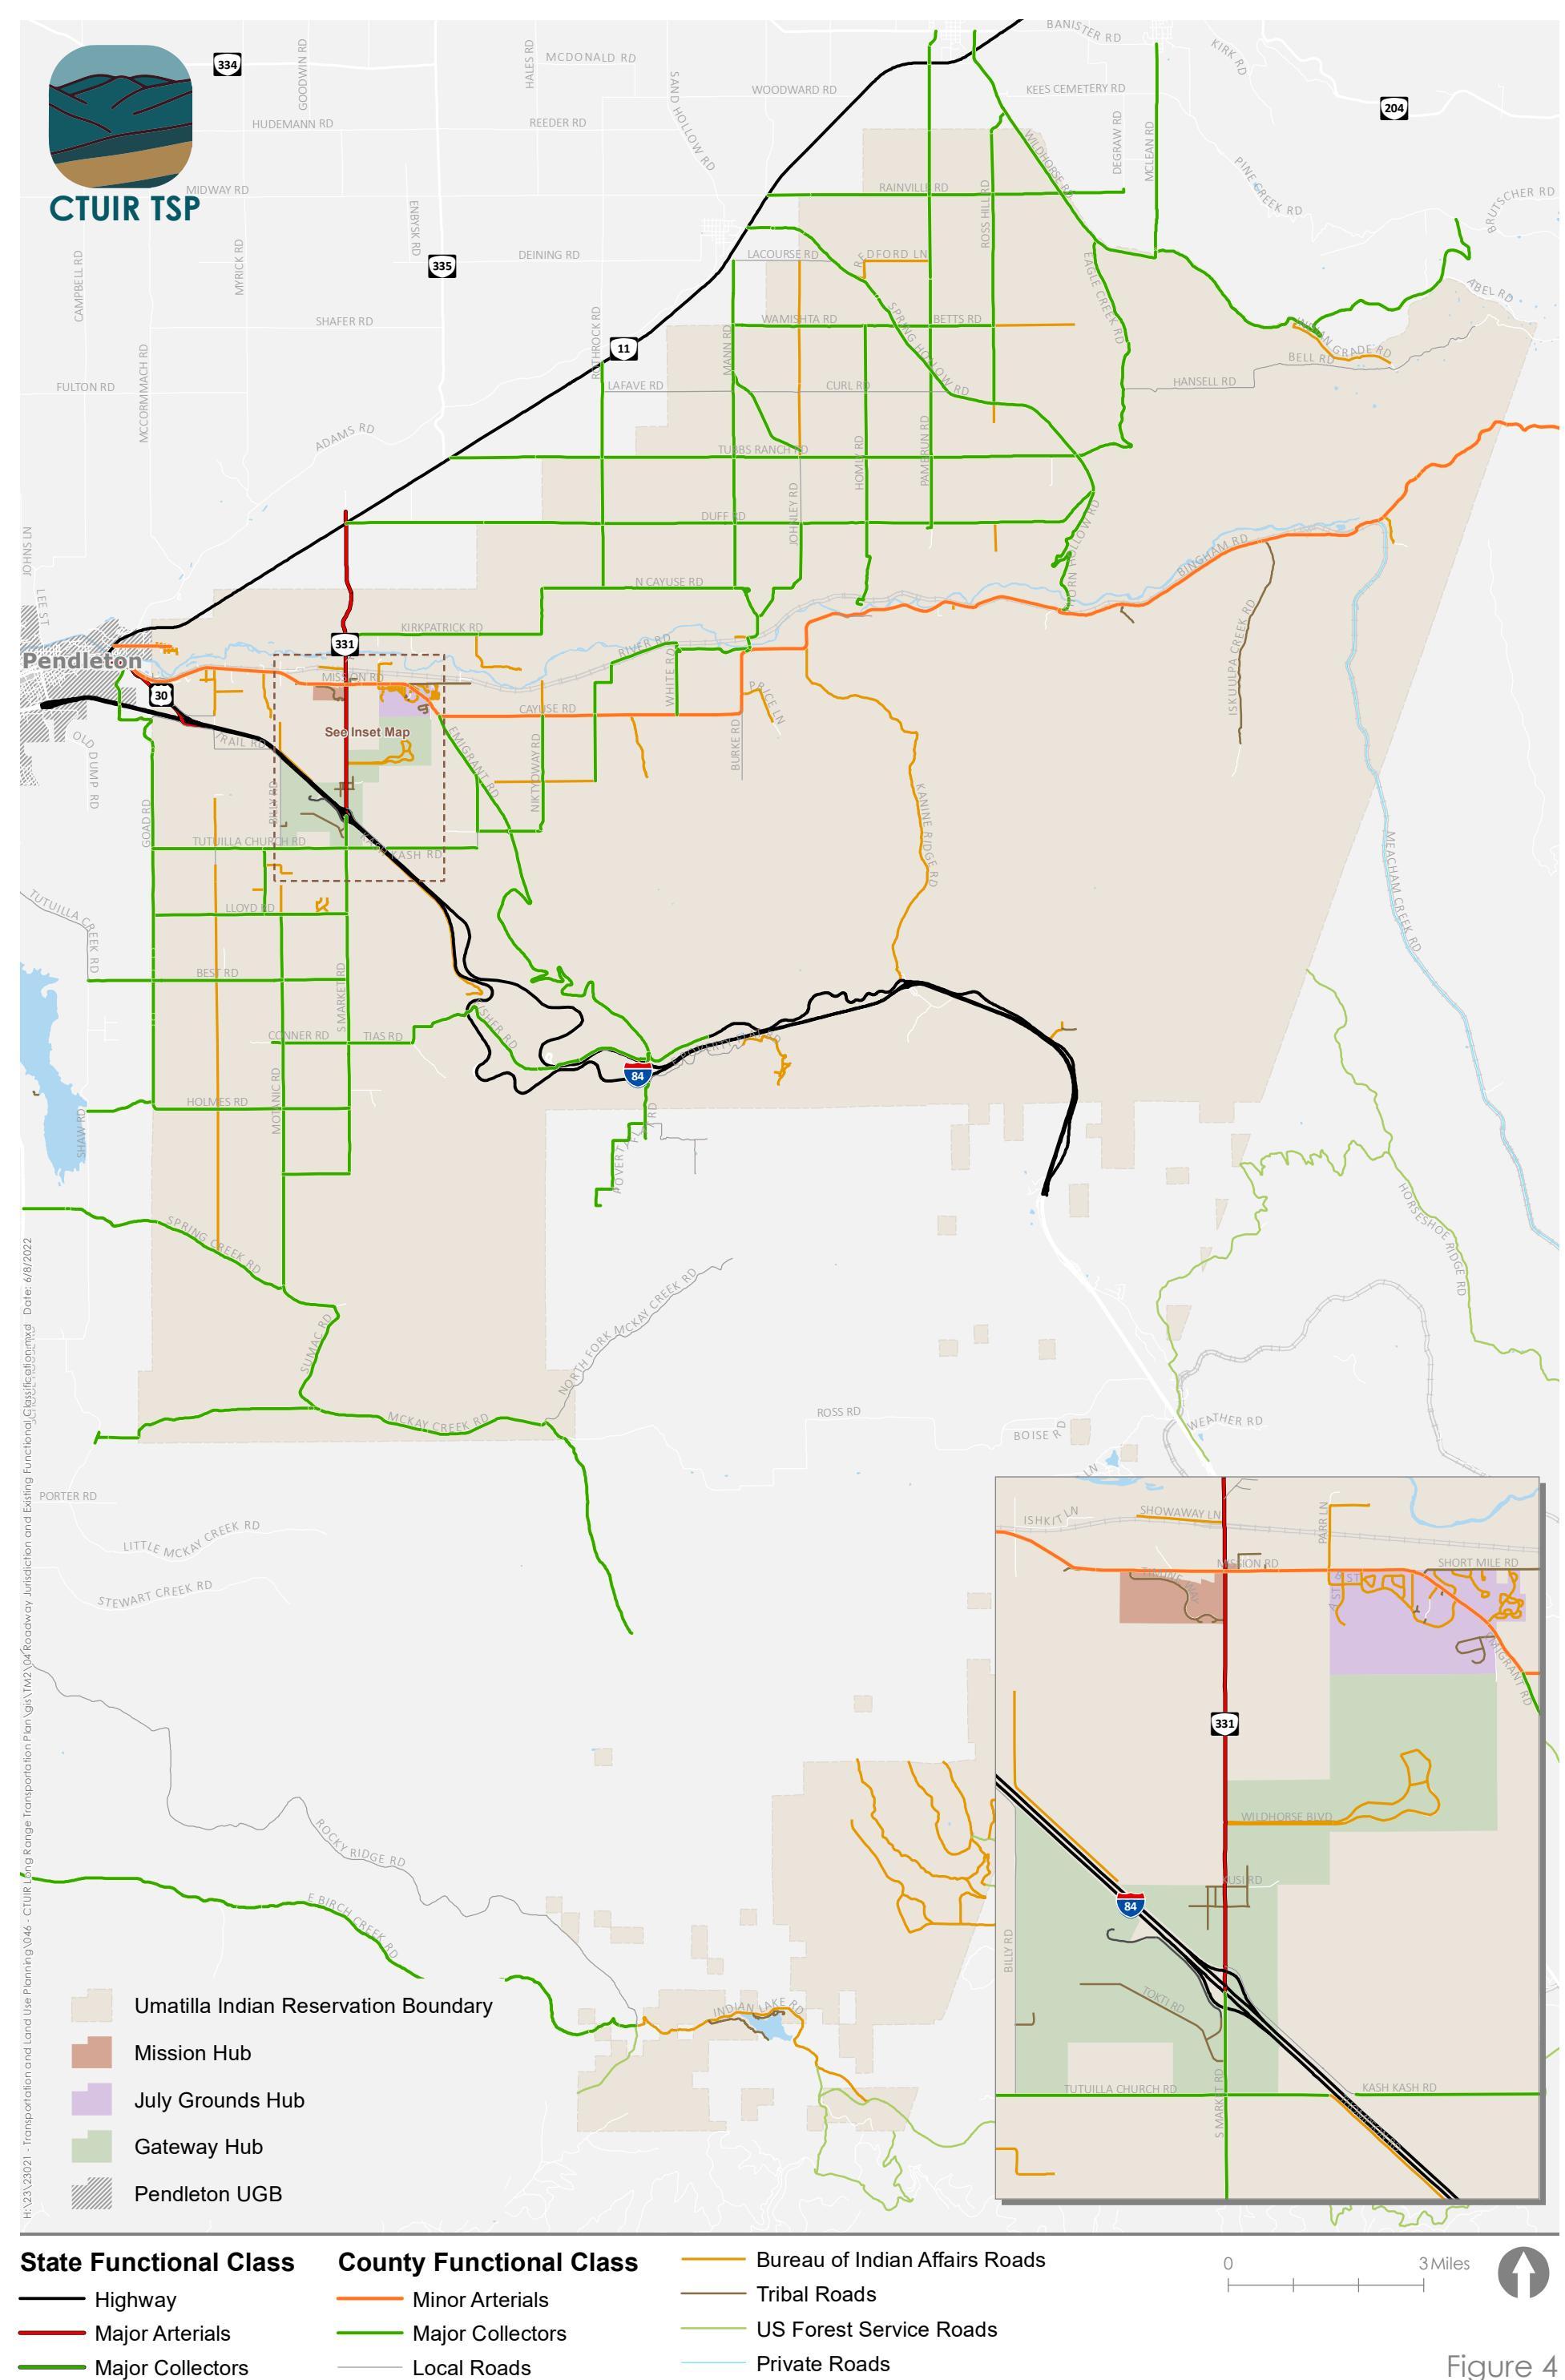
Figure 4

Roadway Jurisdiction and Existing Functional Classification Umatilla Indian Reservation

The roadway network is owned and operated by multiple entities, consisting of CTUIR, ODOT, Umatilla County, and the Bureau of Indian Affairs (BIA). Each jurisdiction is responsible for determining the functional classification of the streets, defining major design and multimodal features, and approving construction and access permits. Coordination is required among the jurisdictions to ensure that the streets are planned, operated, maintained, and improved to safely meet public needs. Figure 3 illustrates the jurisdiction and functional classification of streets within the UIR boundary.

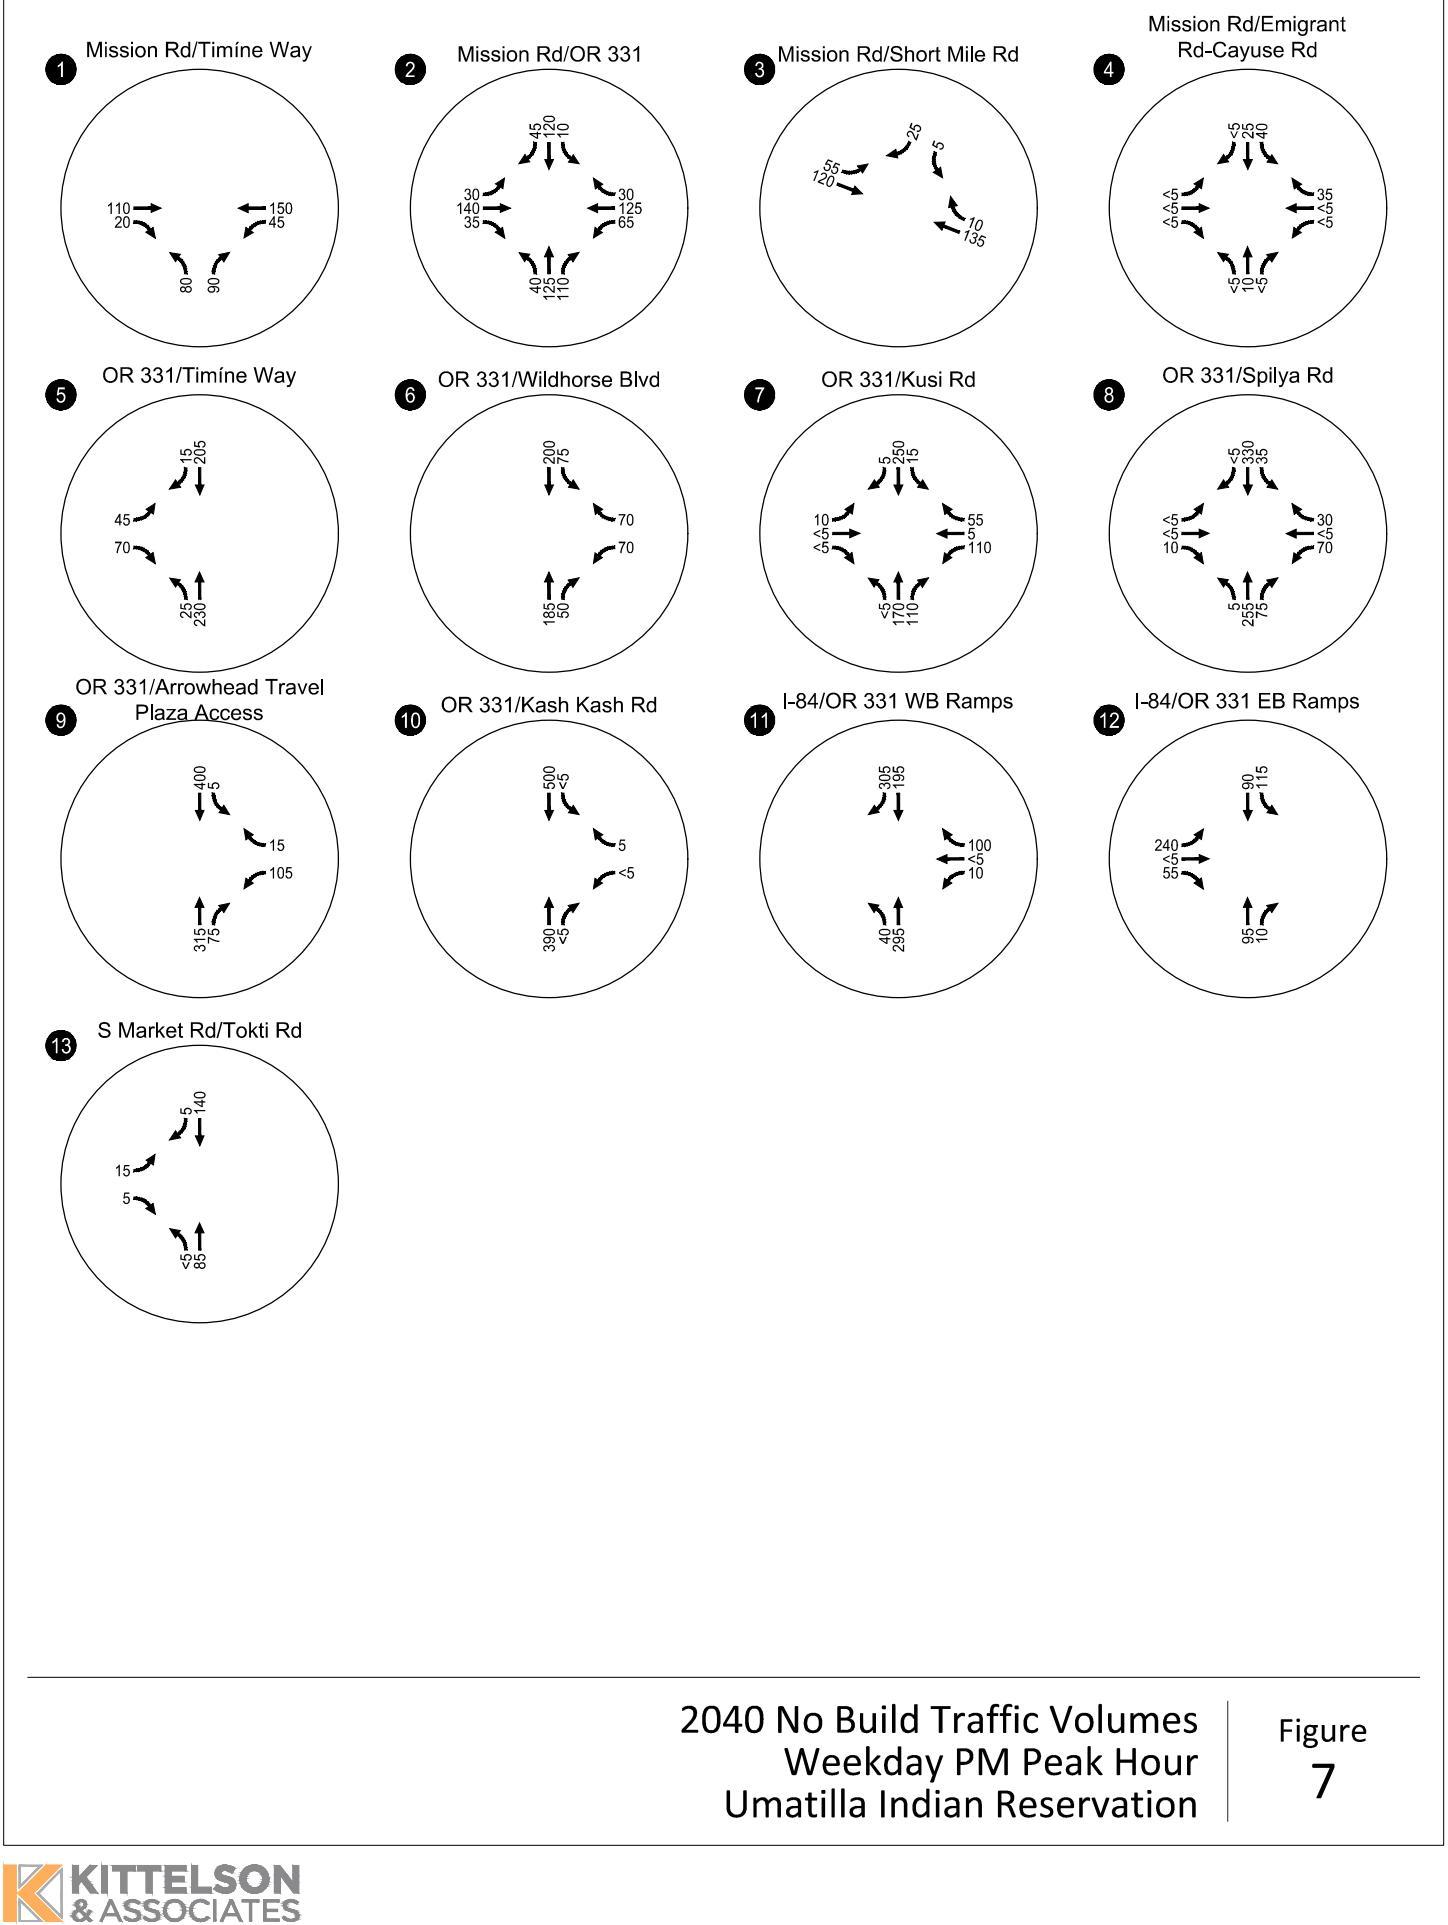
Figure 7 illustrates the year 2040 forecast traffic volumes at the study intersections during the weekday PM peak hour. Table 2 summarizes the results of the future traffic operations analysis at the study intersections under year 2040 traffic conditions.

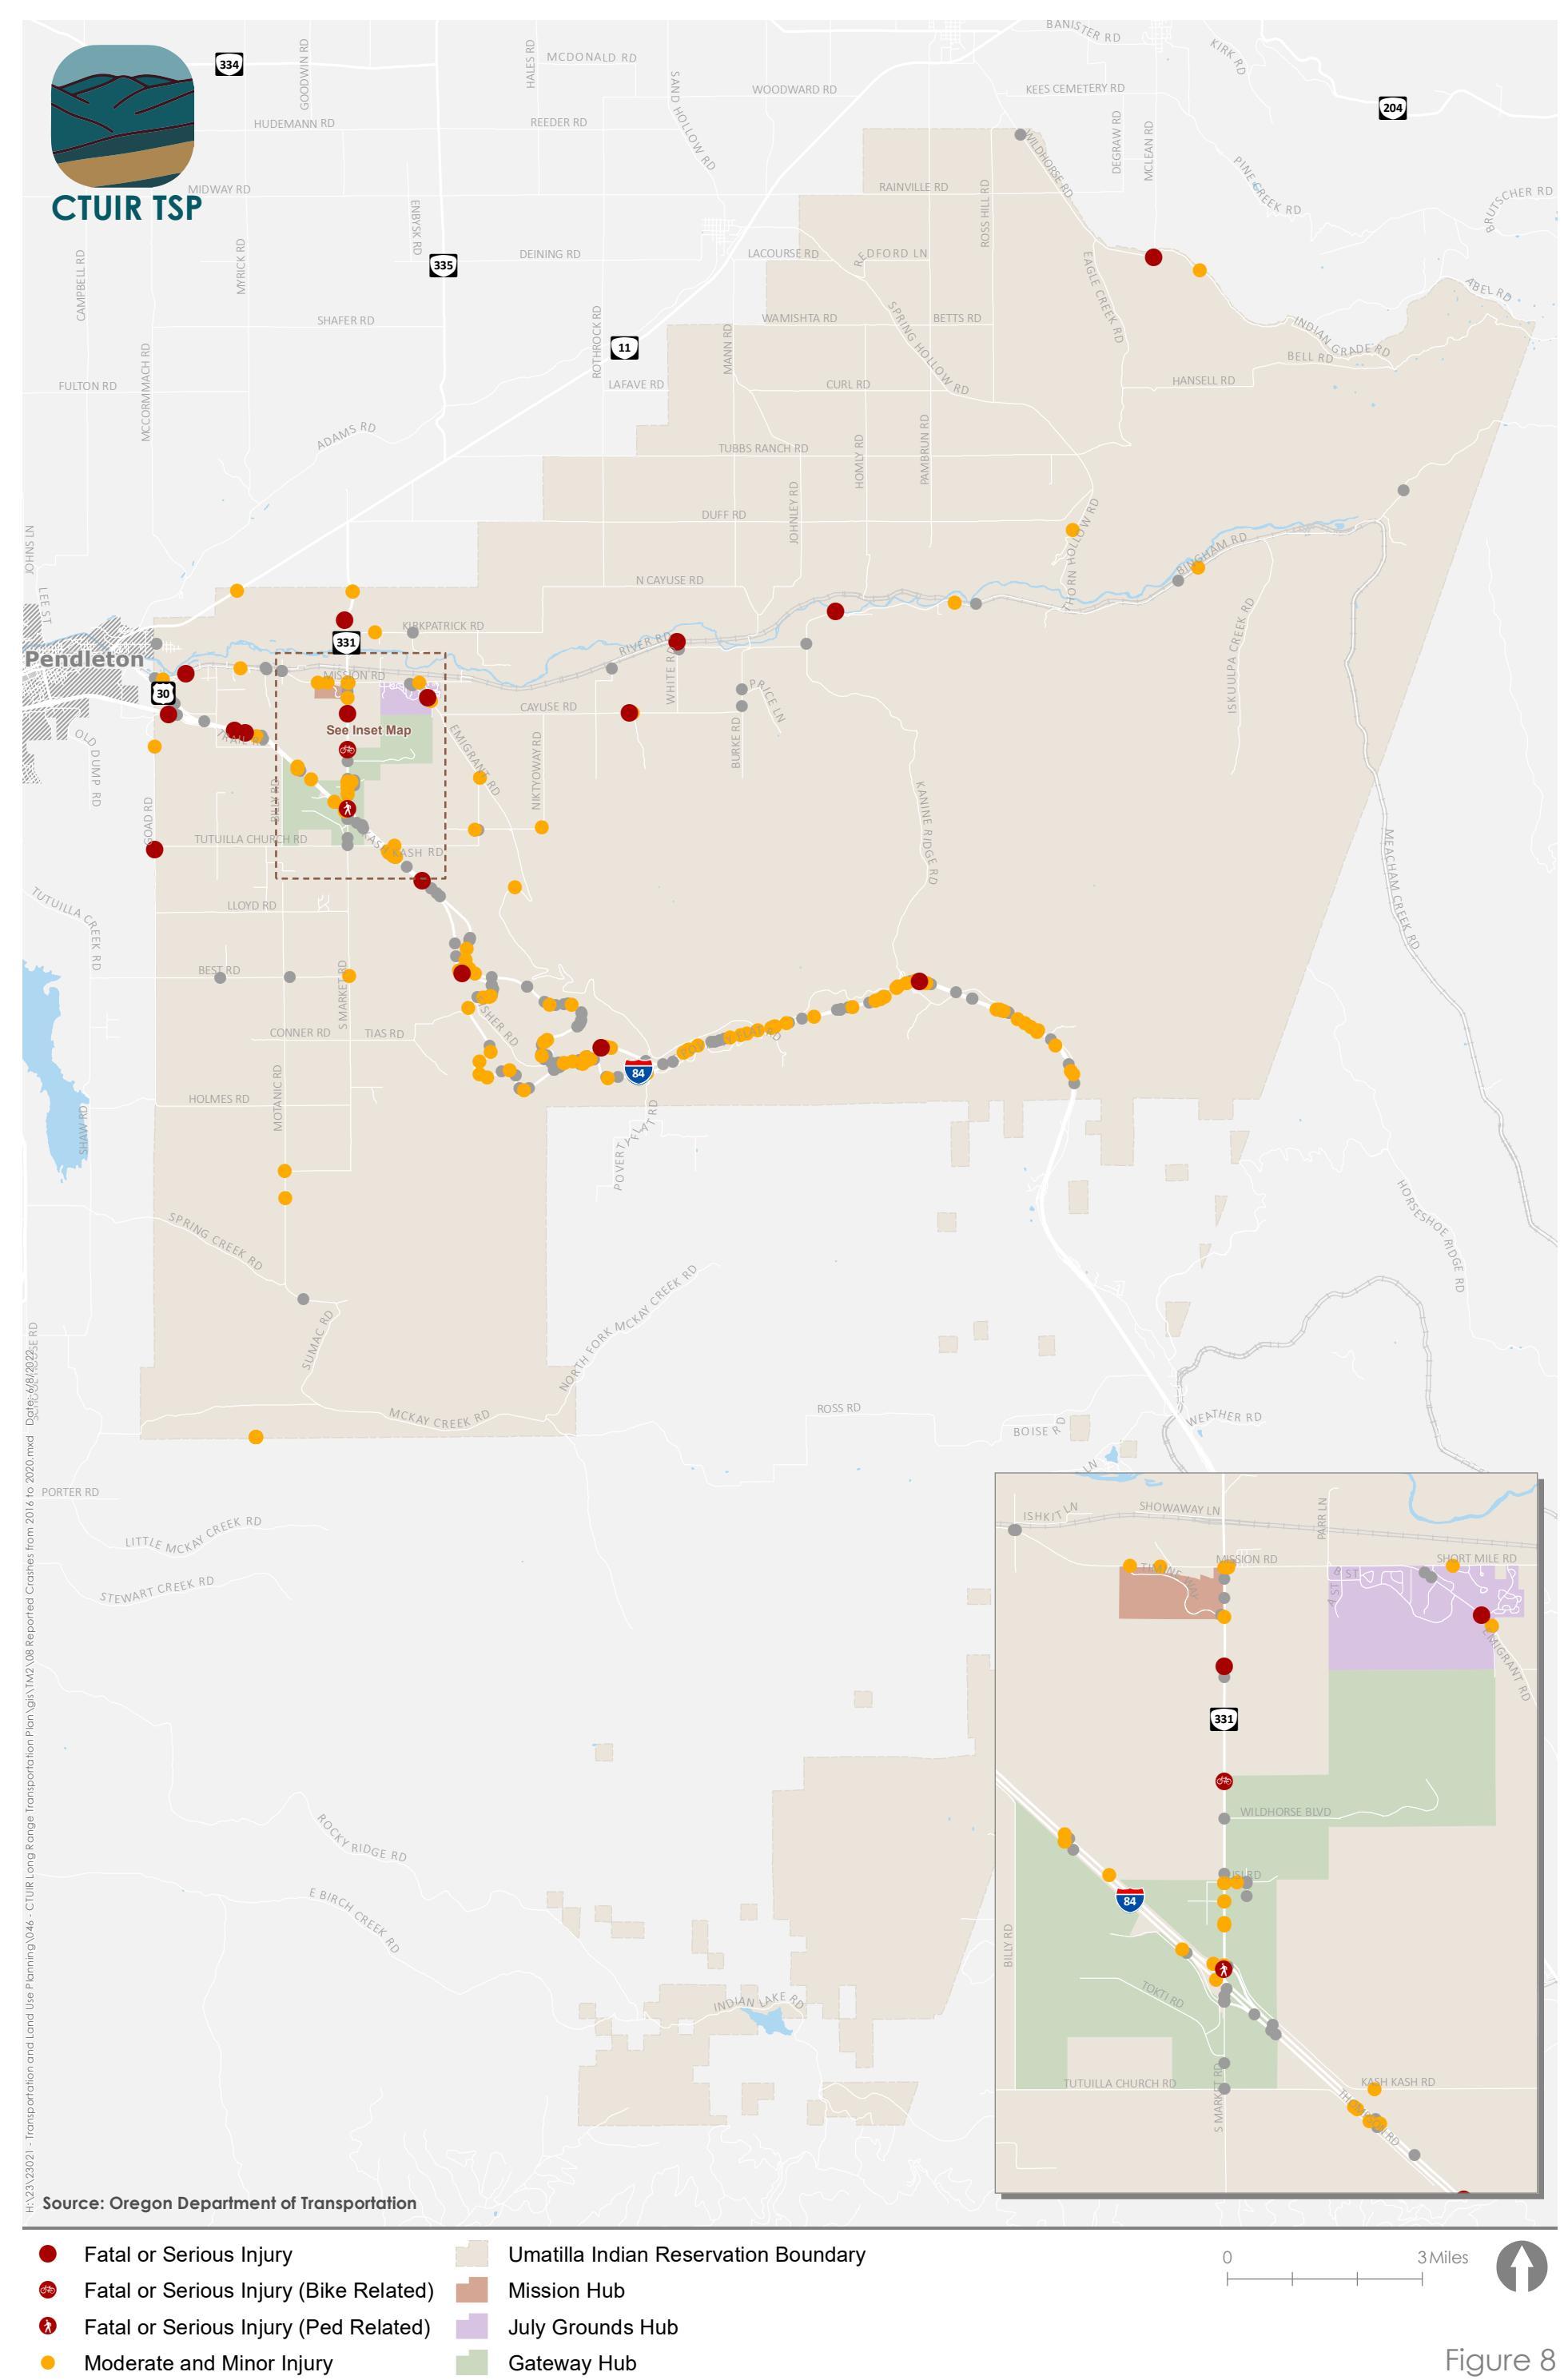
Reported Crashes 2016 - 2020 Umatilla Indian Reservation

Crash records were obtained from ODOT for the five-year period from January 1, 2016 through December 31, 2020 for the overall study area. Figure 8 illustrates the location, severity, and type of crashes that occurred within the study area over the five-year period. Based on the data, a total of 392 crashes occurred within the UIR, of which six resulted in a fatality, 12 resulted in suspected serious injuries, 135 resulted in suspected moderate or minor injuries, and 239 resulted in property-damage-only. Most (256) of the crashes within the UIR occurred on I-84, including three of the crashes resulting in fatalities and four of the crashes resulting in suspected serious injuries. There were 136 crashes reported within the UIR boundary outside I-84, including three fatal crashes and eight suspected serious injury crashes. The following summarizes the results of the intersection and segment crash analysis based on the five years of crash data.

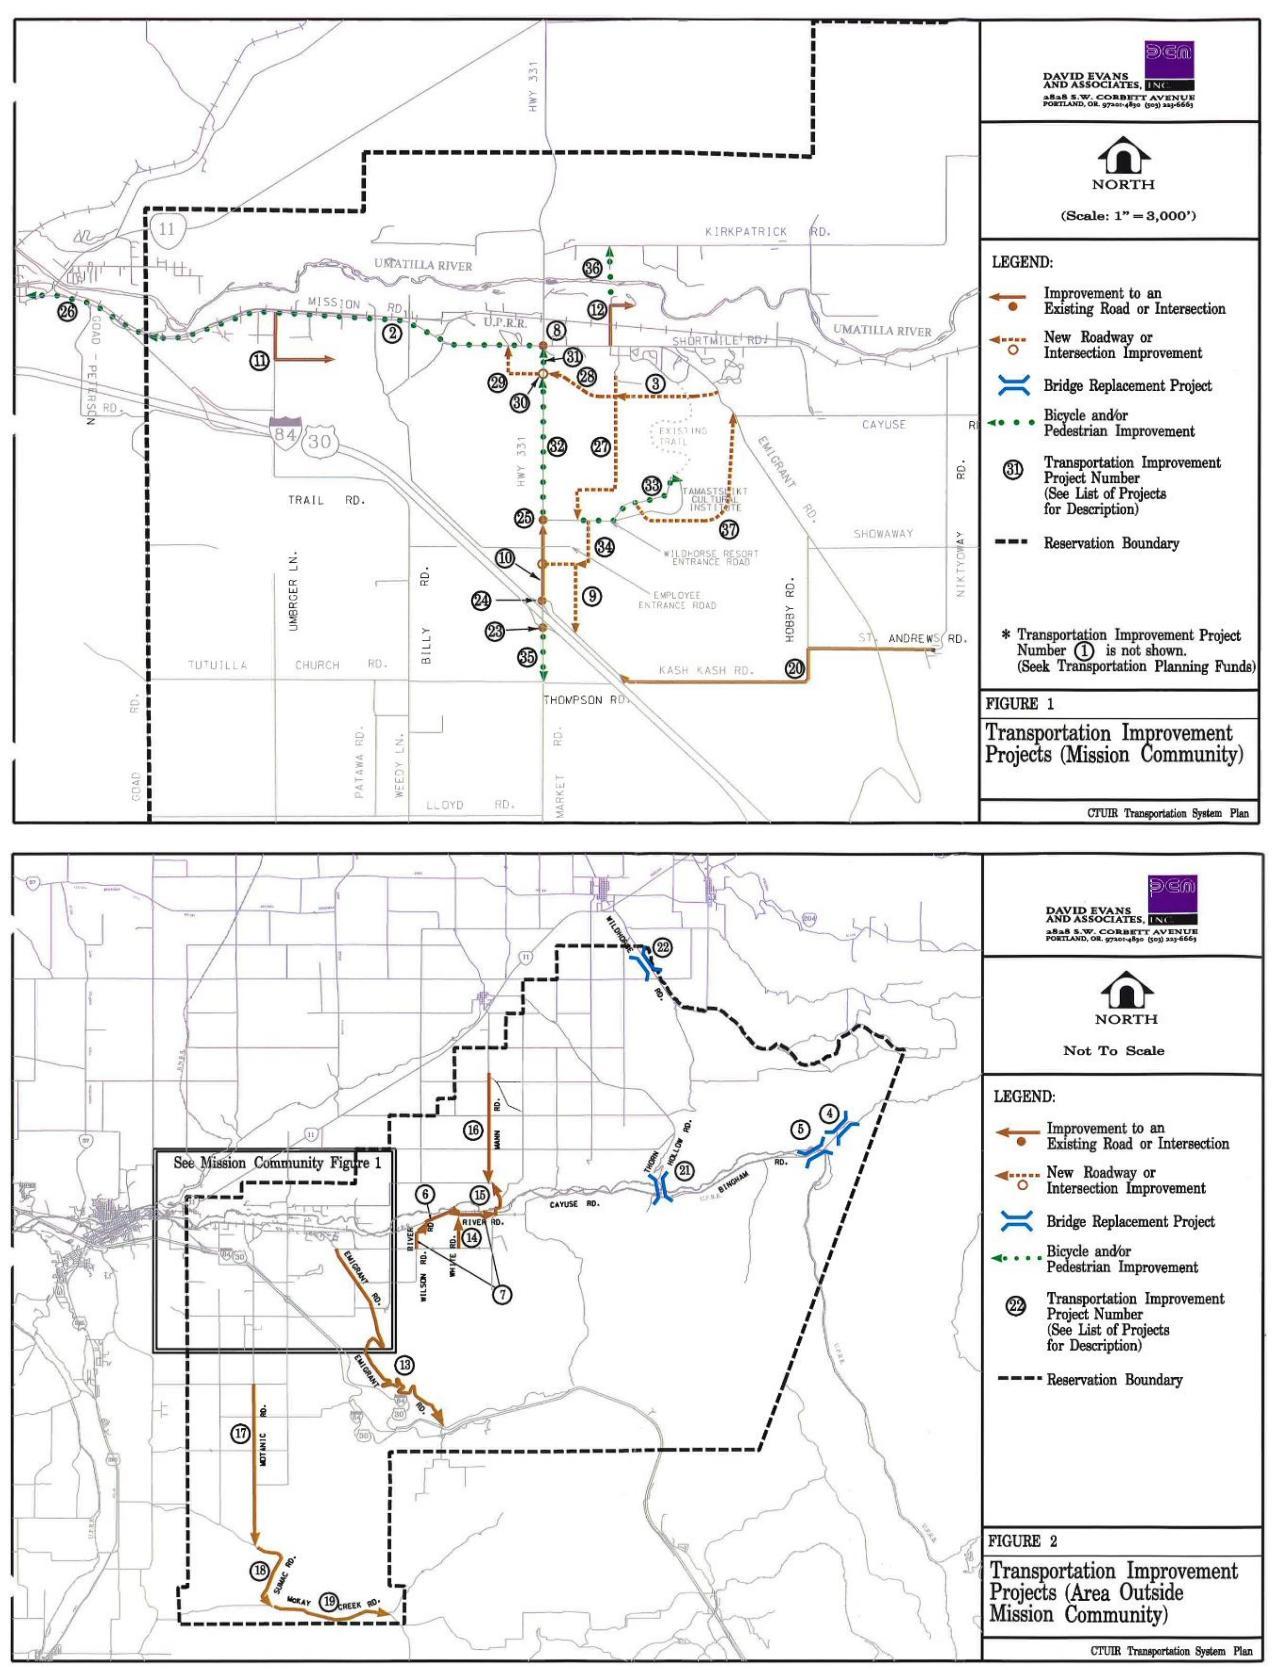
Figure 9: 2001 CTUIR TSP Project Map

Attachment E contains a list of planned projects and previous feedback provided via the 2001 CTUIR TSP, MCMP, OR 331 Access Management Implementation Strategy and Circulation Plan, and Umatilla County TSP. Most of the previously planned roadway system projects were provided in the 2001 CTUIR TSP. Figure 9 shows the project map from the 2001 CTUIR TSP.

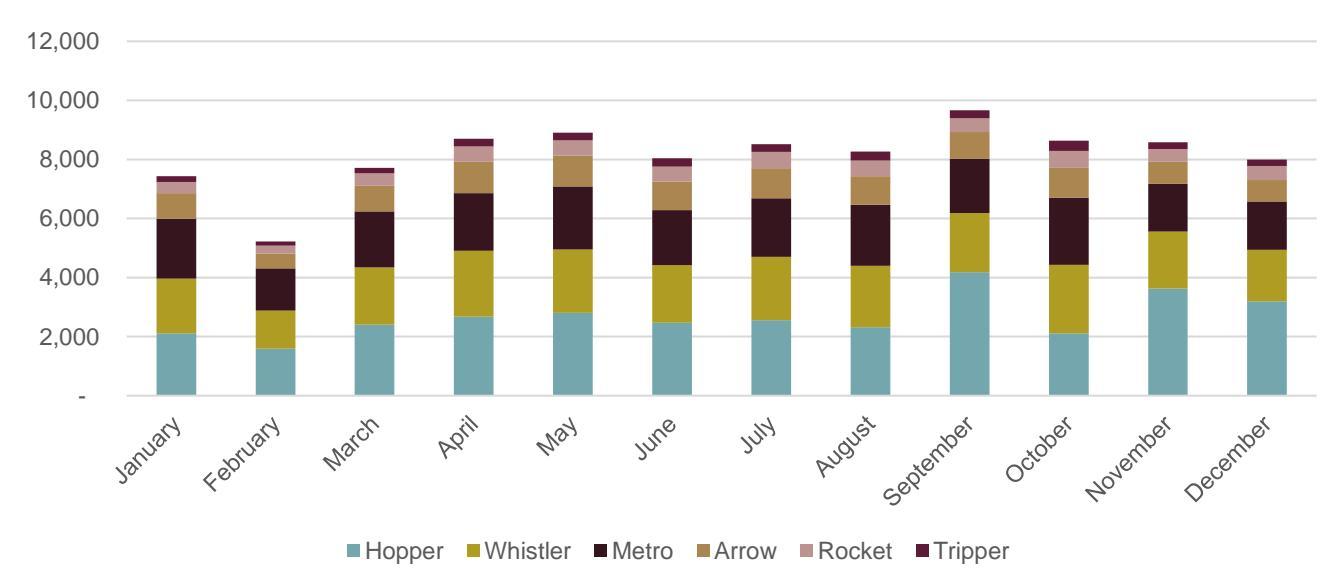
Figure 10: 2019 Ridership for Kayak Routes Serving the Umatilla Indian Reservation

Table 6 and Figure 11 summarize the Kayak routes serving the UIR as of January 2022. CTUIR provides updated Kayak service information and schedules at the beginning of each calendar year. Because of service changes and traveler pattern changes due to COVID-19 during 2020 and 2021, the ridership for 2019 is shown for each route. In addition, Figure 10 provides a monthly overview of ridership during 2019 for the routes serving the UIR area. As shown, the highest monthly ridership during 2019 was approximately 9,670 rides in September. The lowest monthly ridership was approximately 5,225 rides in February.

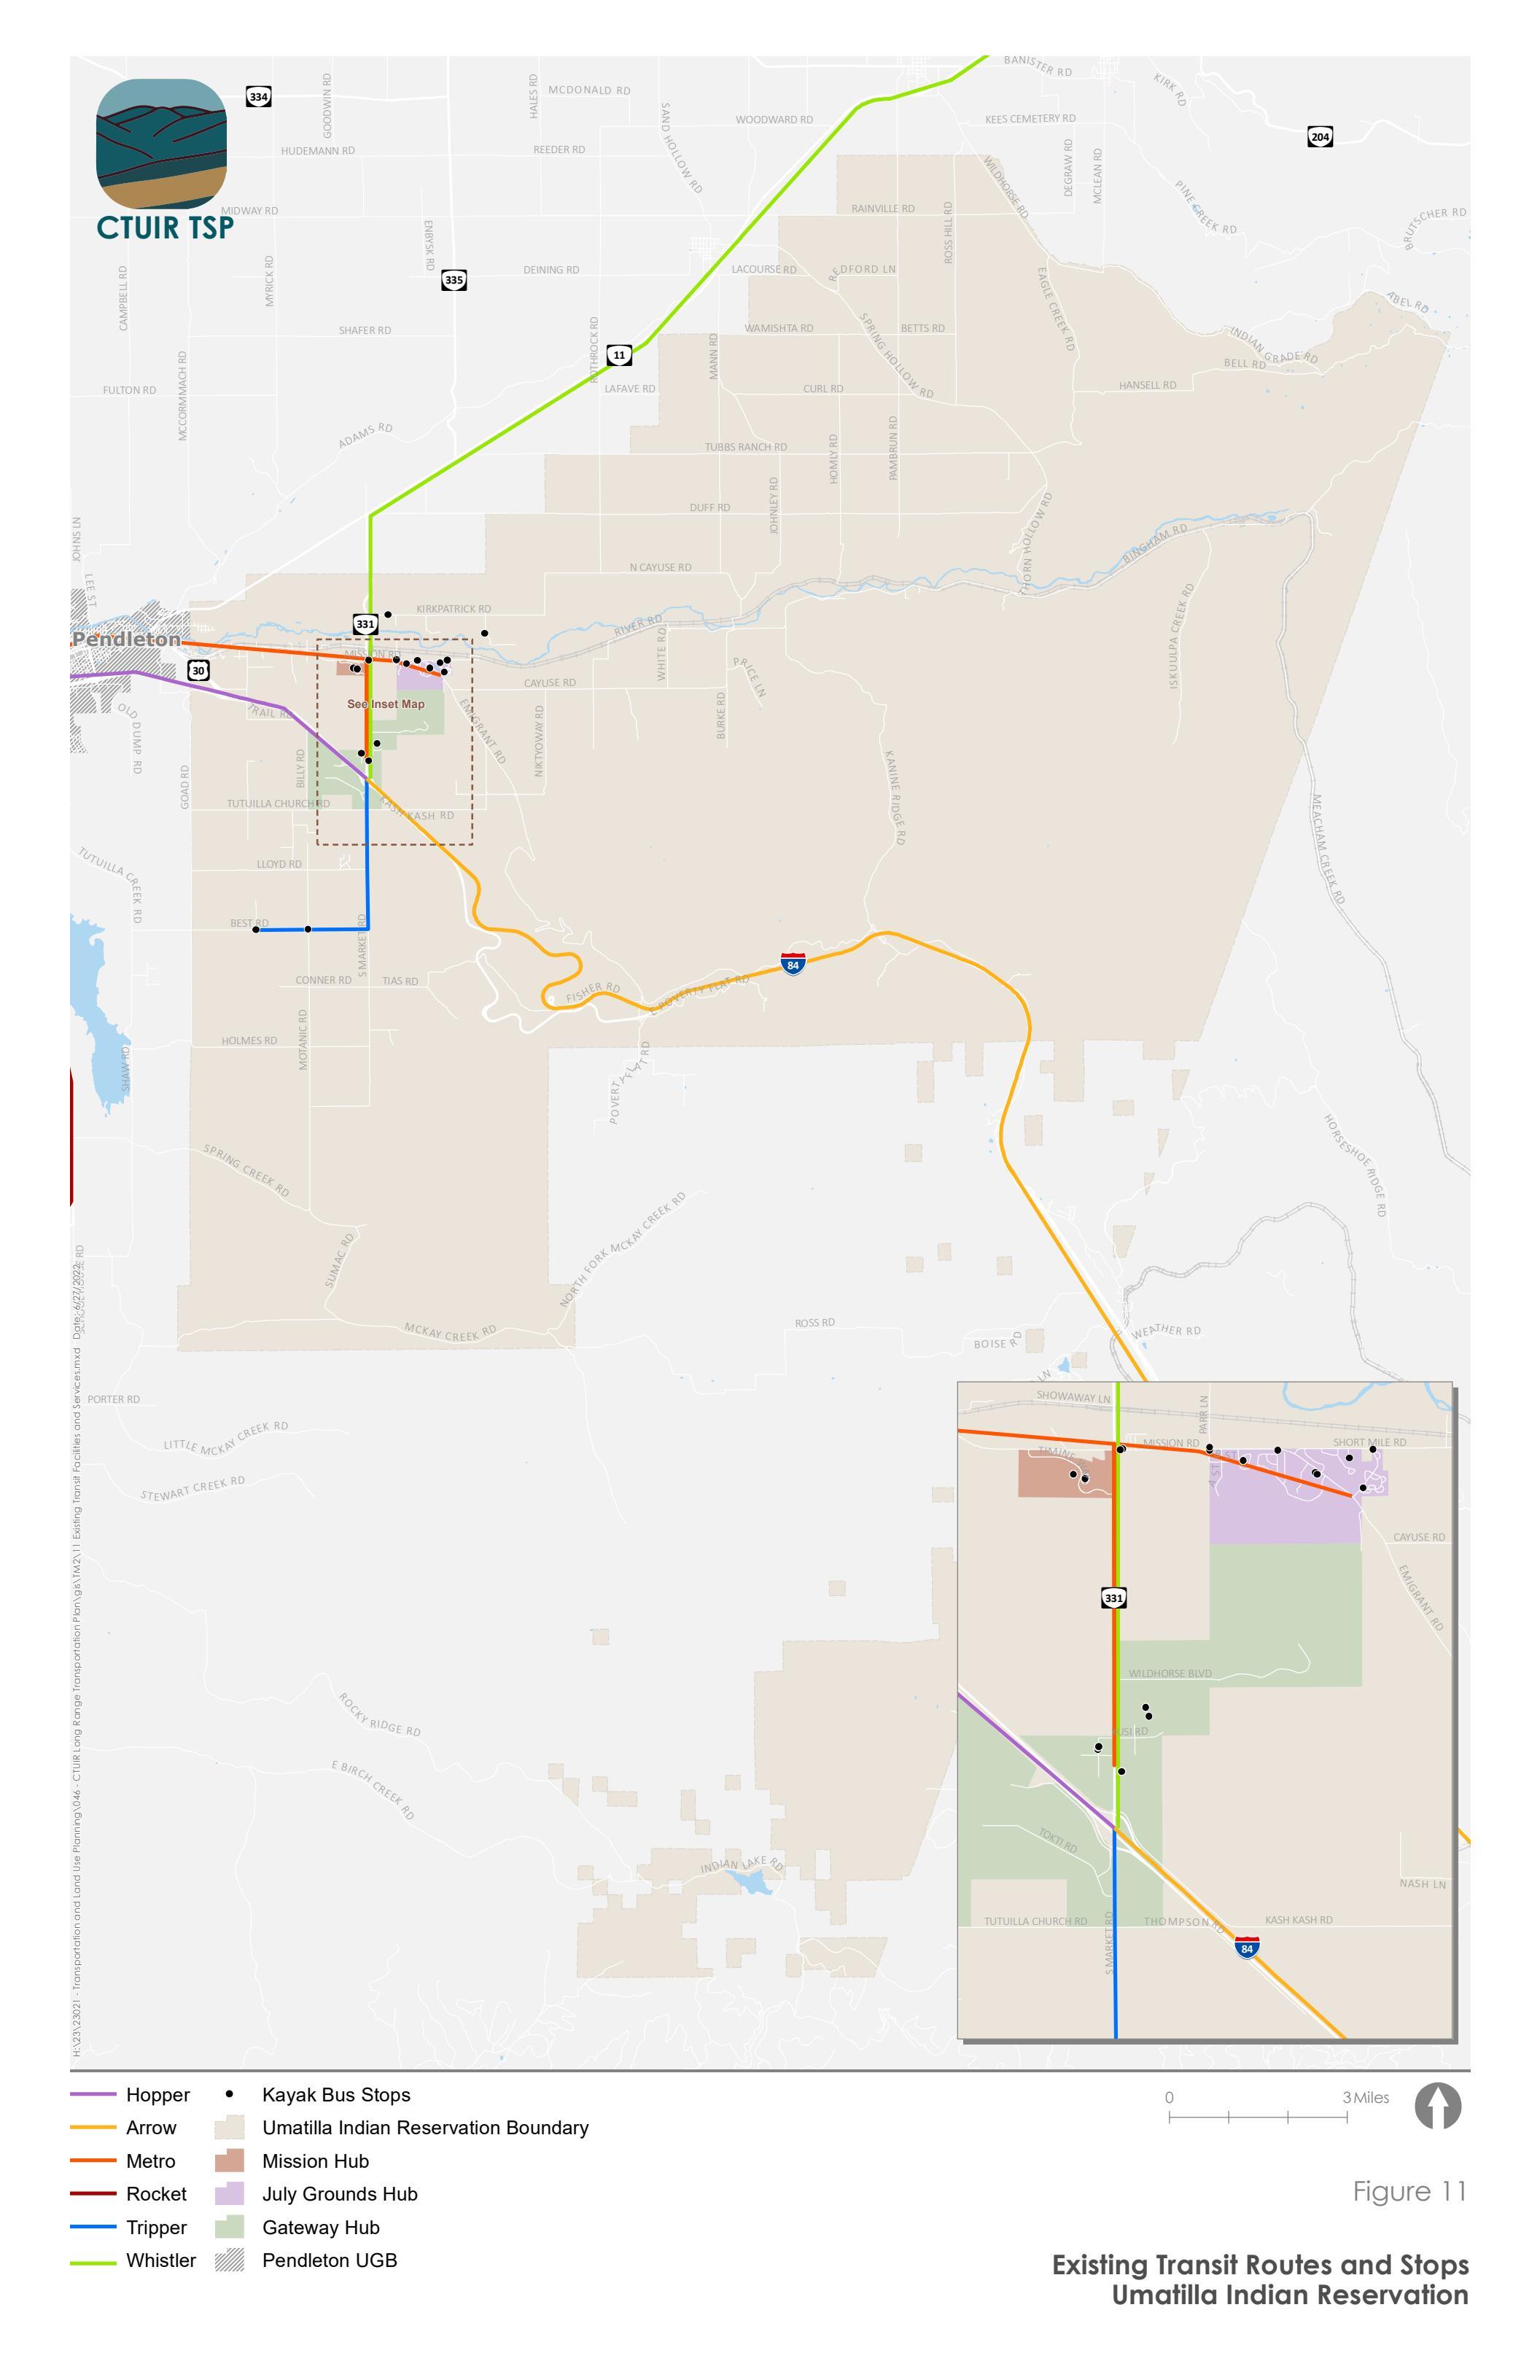
As of January 2022, there are 18 Kayak bus stops located within the UIR boundary and shown in Figure 11. Eight of the stops have shelters available for waiting riders and seven have sidewalks immediately adjacent to the stop. No bus stops within the UIR boundary have designated bicycle facilities (e.g., bike lanes or multi-use paths) immediately adjacent.
